## **Asbestos Assessment**

Thomas J Mahoney  
57 Stuart Street, Hamilton, ON, L8L  
1B5

**Hamilton-Wentworth Catholic  
District School Board**

August 31, 2023

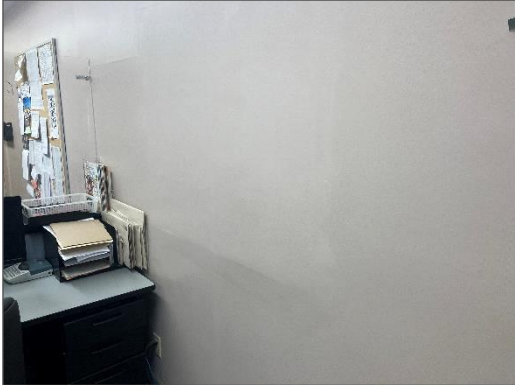
Material and Application	Asbestos Type	Photo
<p>Drywall joint compound is present on wall and ceiling finishes.</p>	<p>Chrysotile</p>

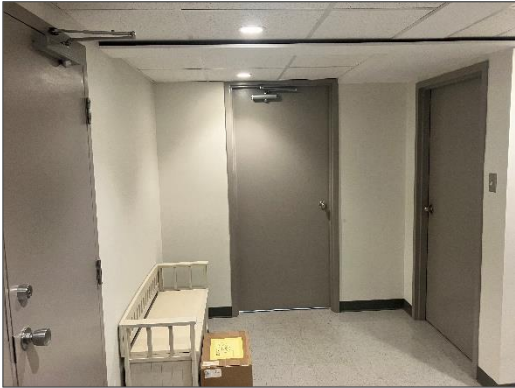
<p>Asbestos in drywall joint compound was banned in Canada in 1980. Drywall was installed during renovations in various locations after 1986 (1980 plus a reasonable non-compliance period based on our experience) and the drywall joint compound is assumed to contain no asbestos.</p>	<p>None</p>	
<p>Vinyl floor tiles and mastic are presumed to be non-asbestos based on historical knowledge of the date of installation.</p>	<p>None</p>
