# Asbestos Assessment

Sacred Heart of Jesus  
5 Hamilton Ave, Hamilton, ON, L8V  
2SC

August 31, 2023

Pinchin File: 320582.004

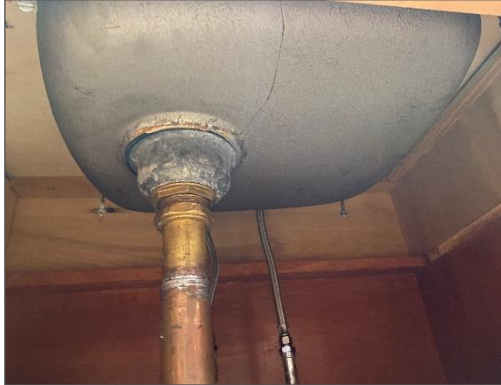
Material and Application	Asbestos Type	Photo
Vinyl floor tiles and mastic are presumed to be non-asbestos based on historical knowledge of the date of installation (2002).	None	
Gold sink undercoating is present.	Presumed

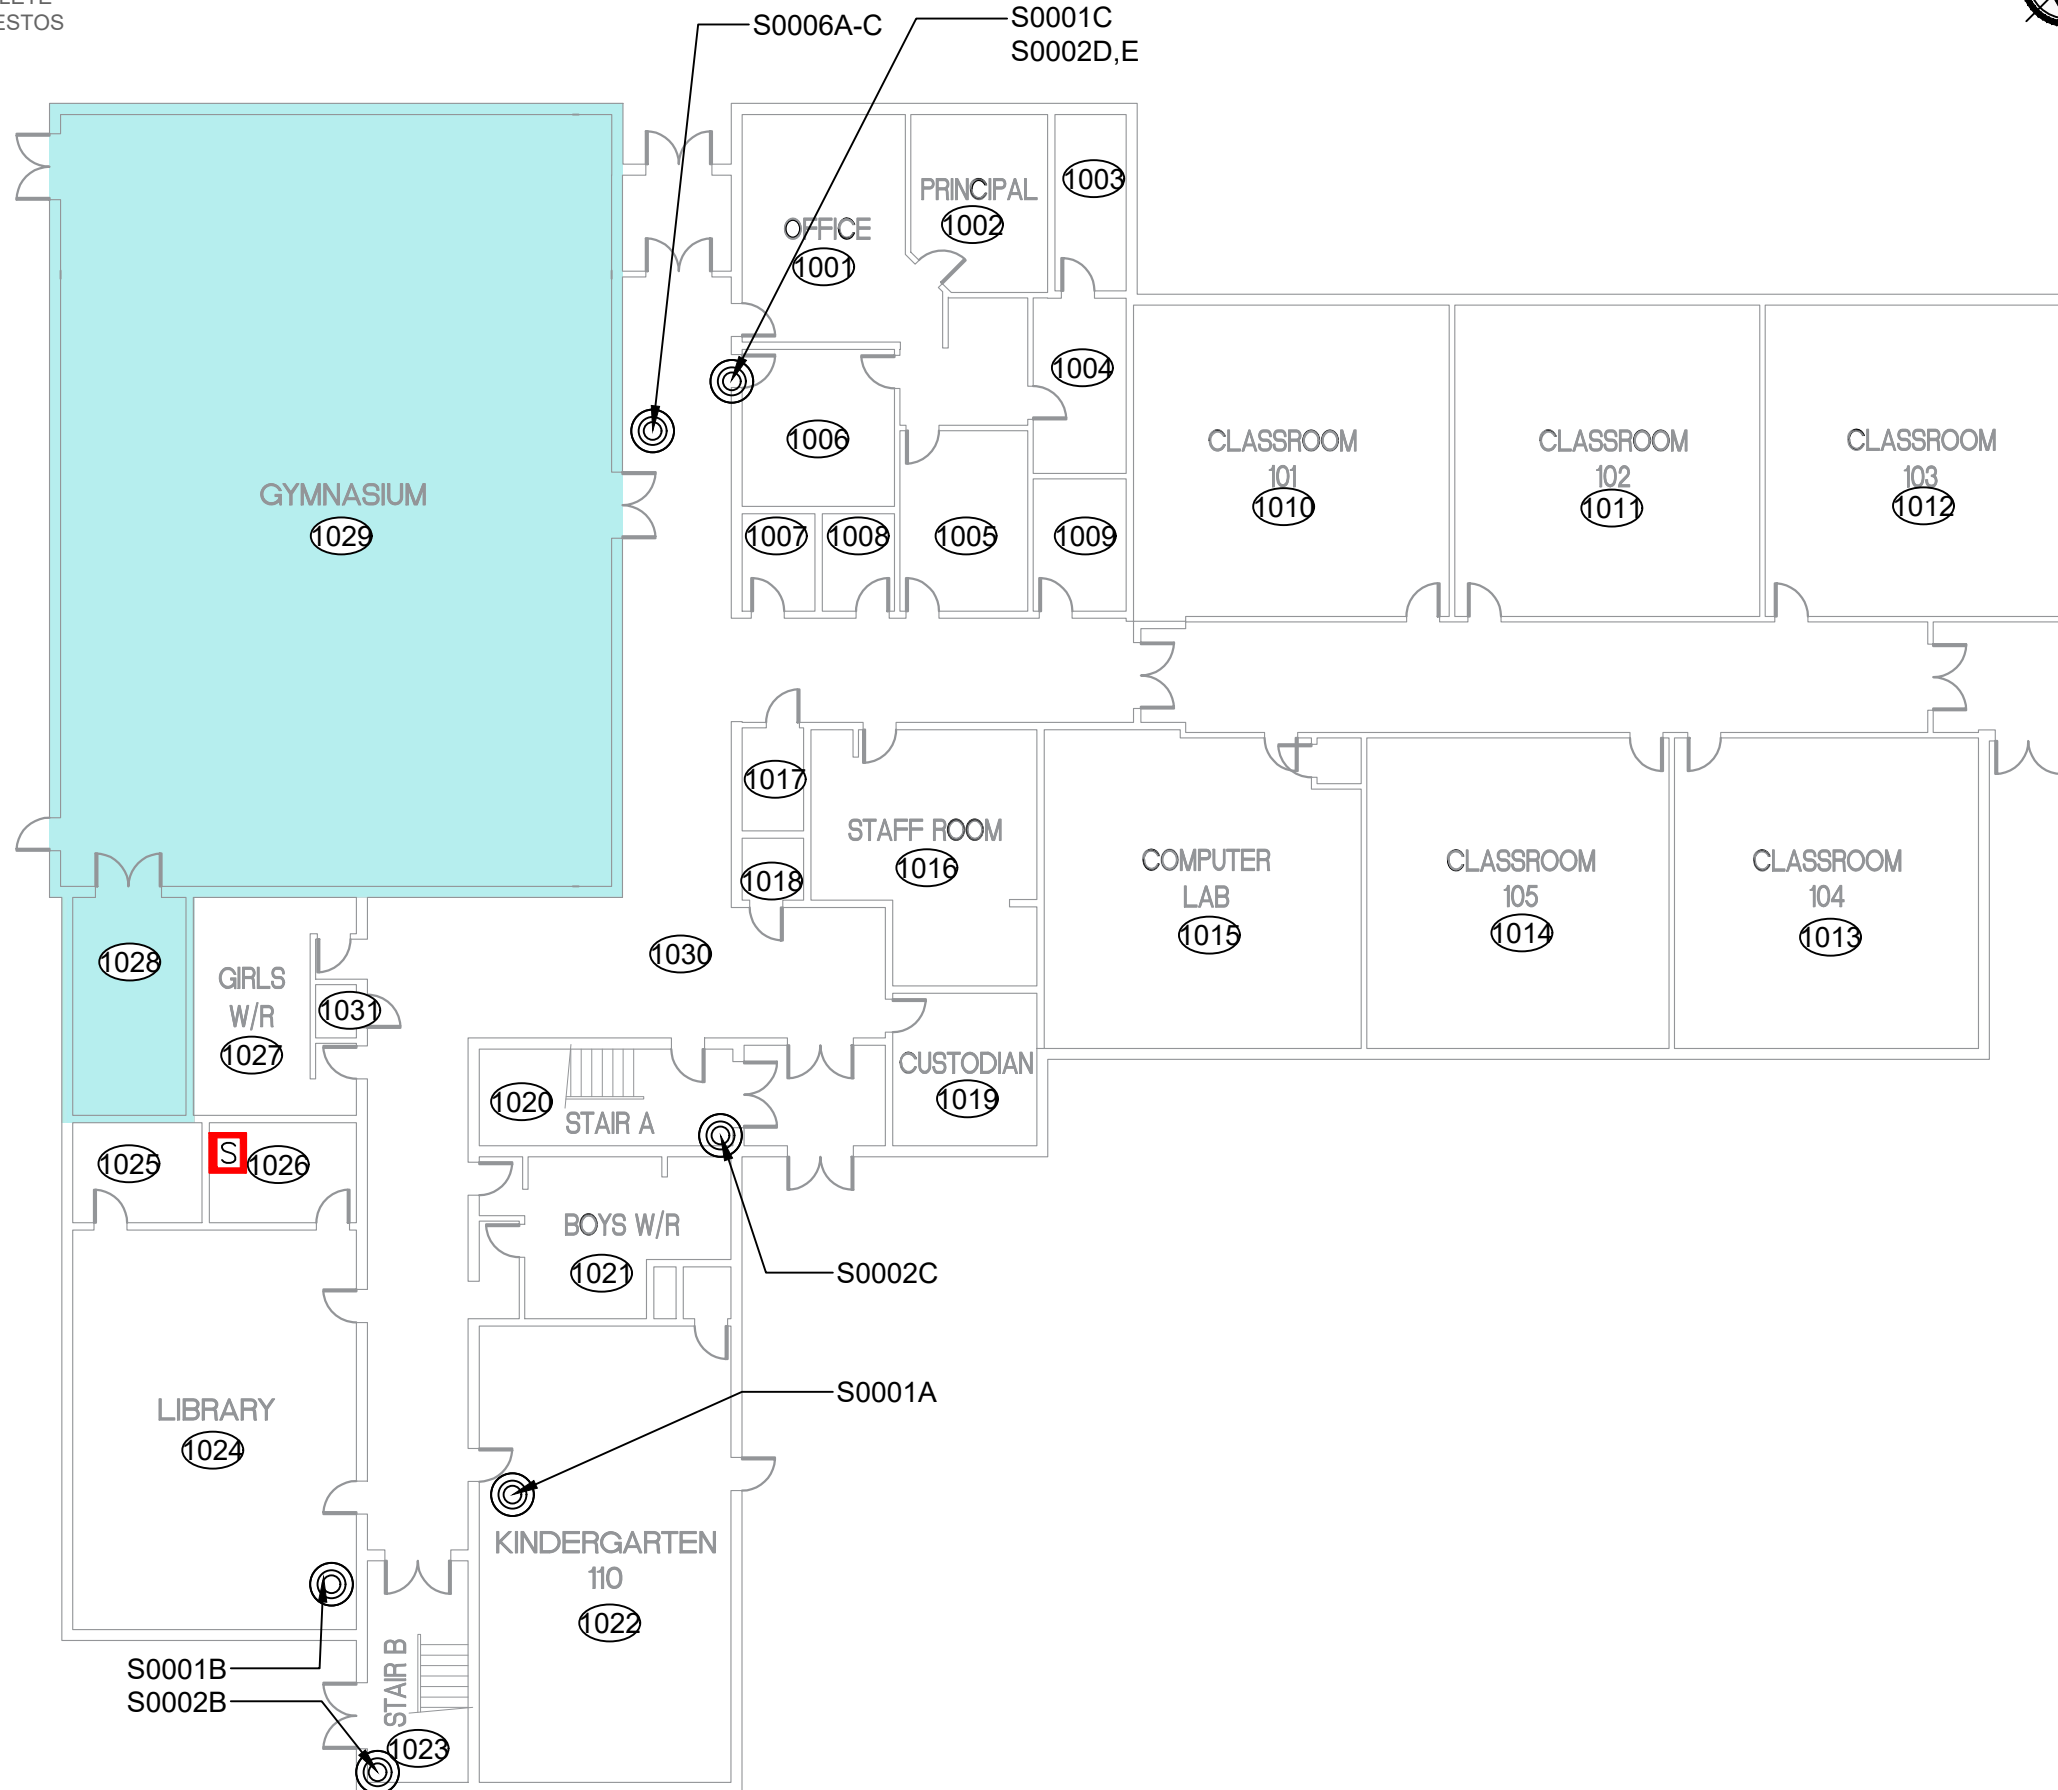
- (X) LOCATION NUMBER
  - (⊙) ASBESTOS BULK SAMPLE
  - NAR NO ACCESS TO ROOM/AREA
- ASBESTOS-CONTAINING MATERIALS:**
- VINYL FLOOR TILES AND MASTIC
  - S SINK UNDERCOATING

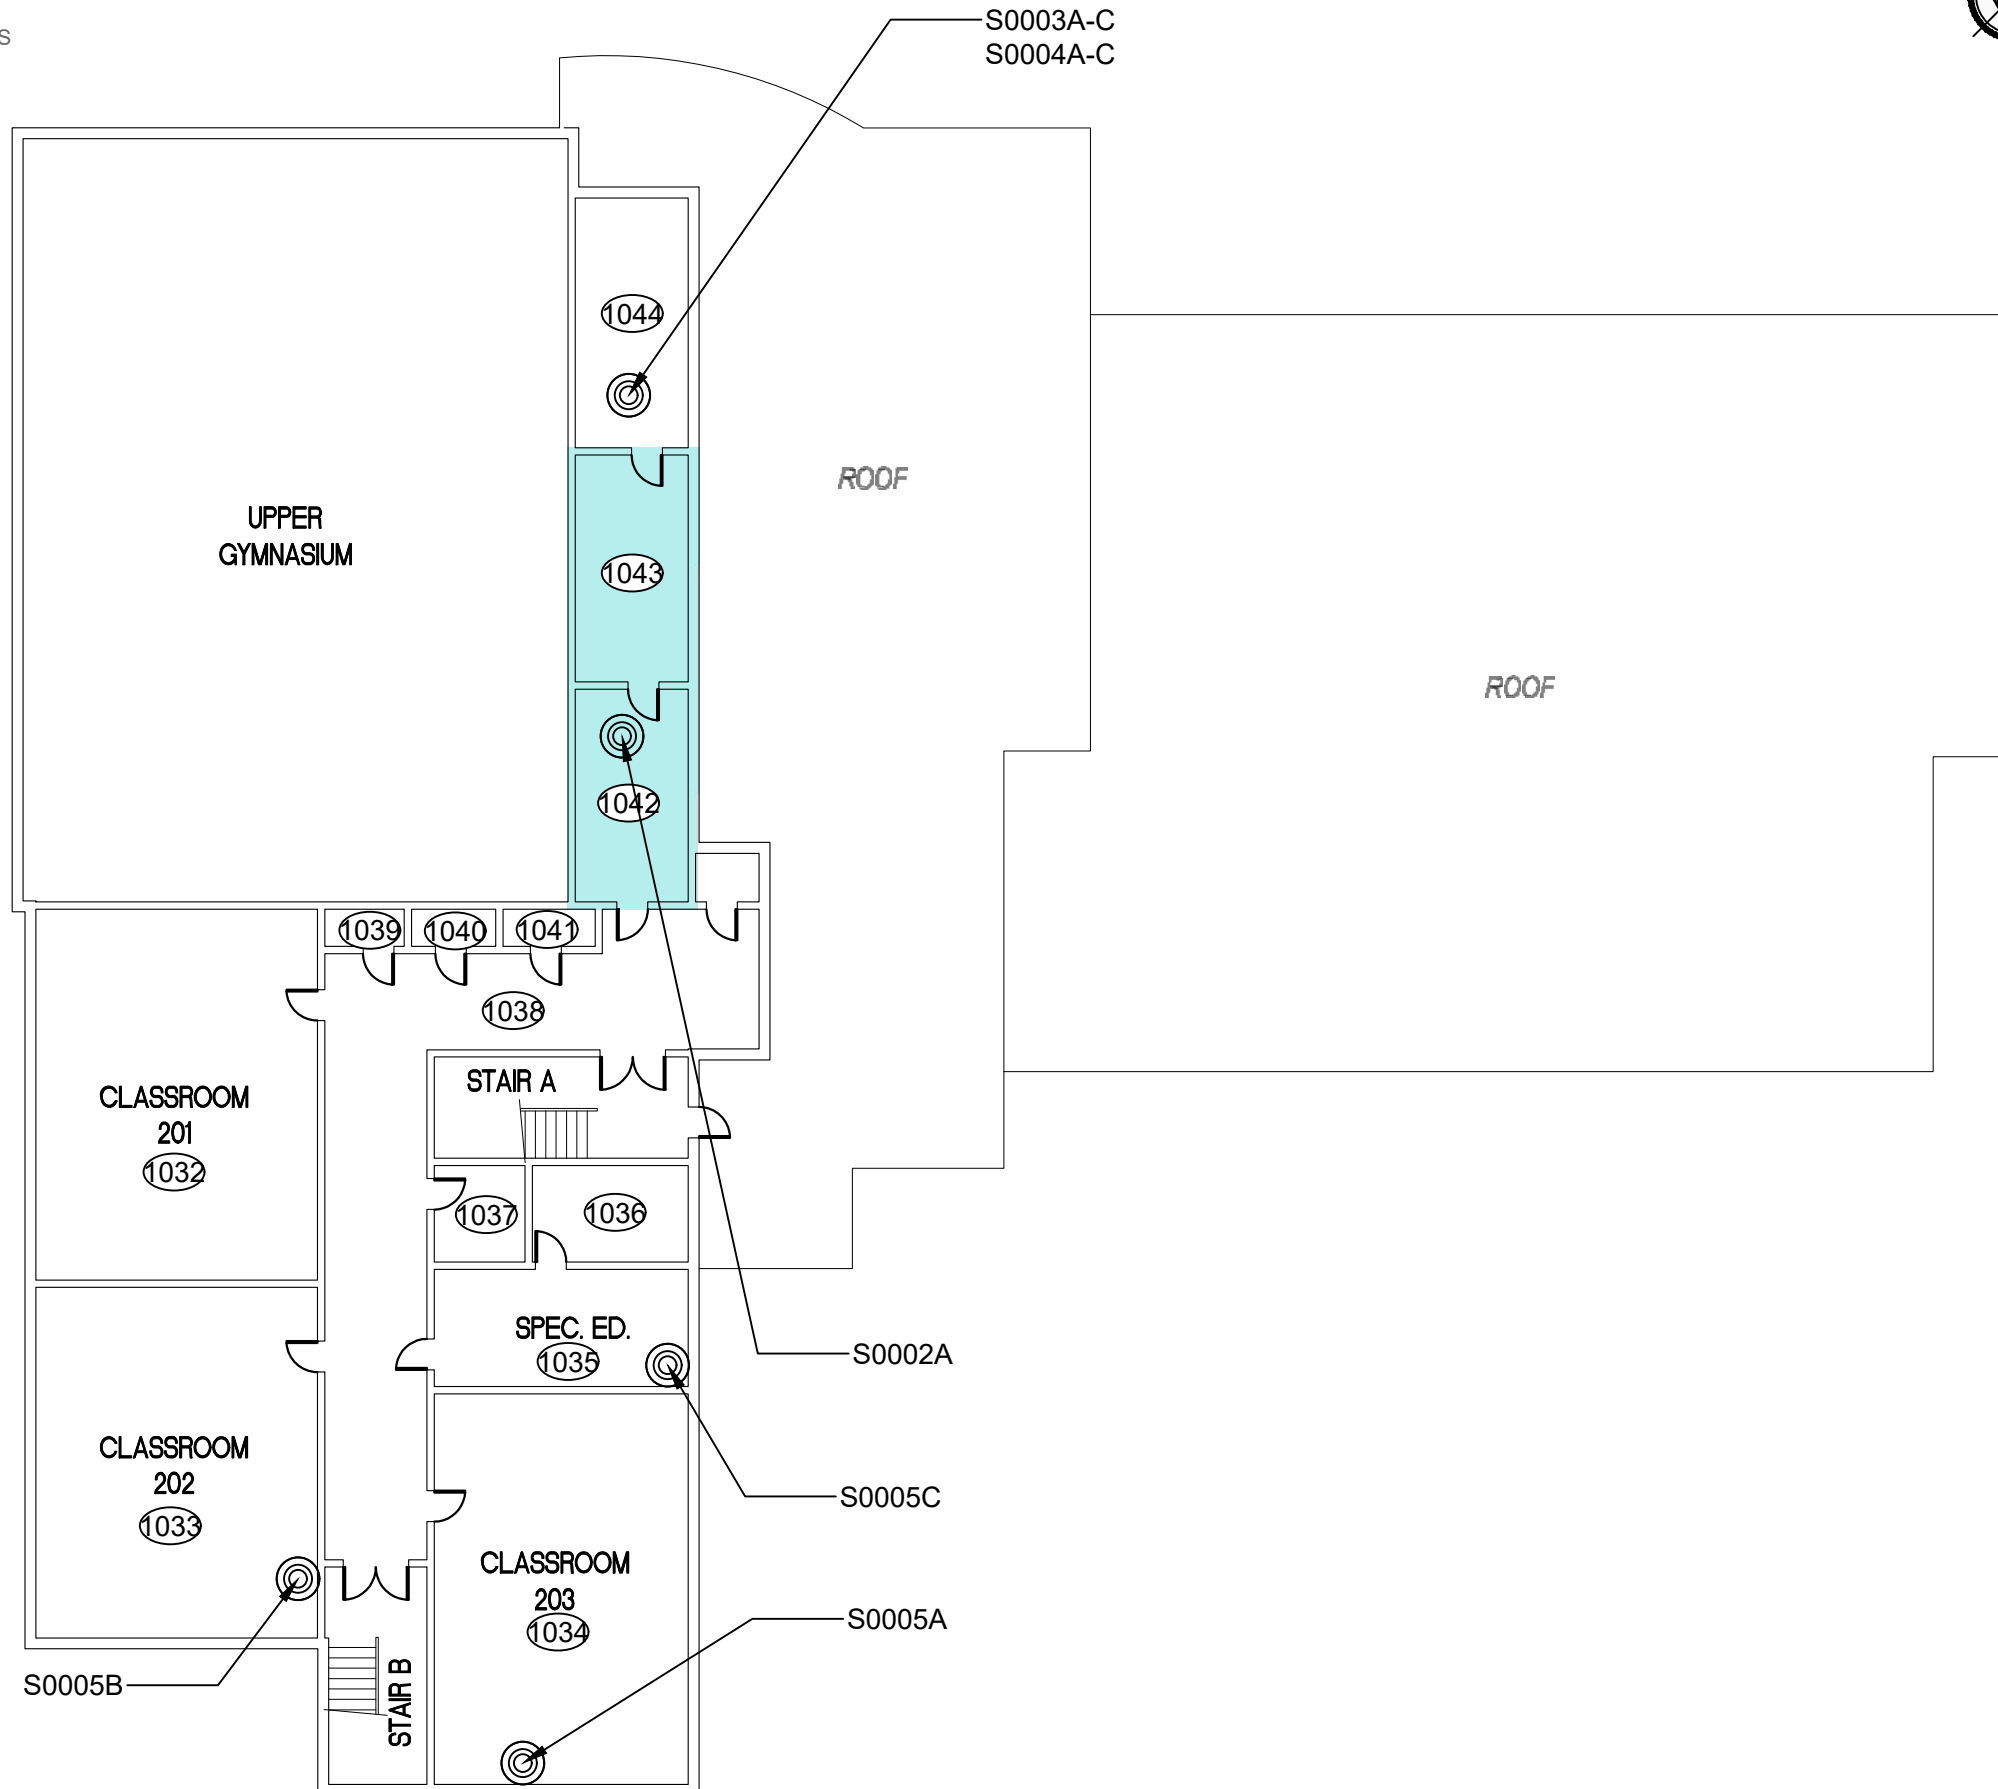
- VINYL FLOOR TILES AND MASTIC
- S SINK UNDERCOATING
