## **Asbestos Assessment**

St. Eugene  
120 Parkdale Avenue South,  
Hamilton, ON, L8K 3P3

**Hamilton-Wentworth Catholic  
District School Board**

August 31, 2023

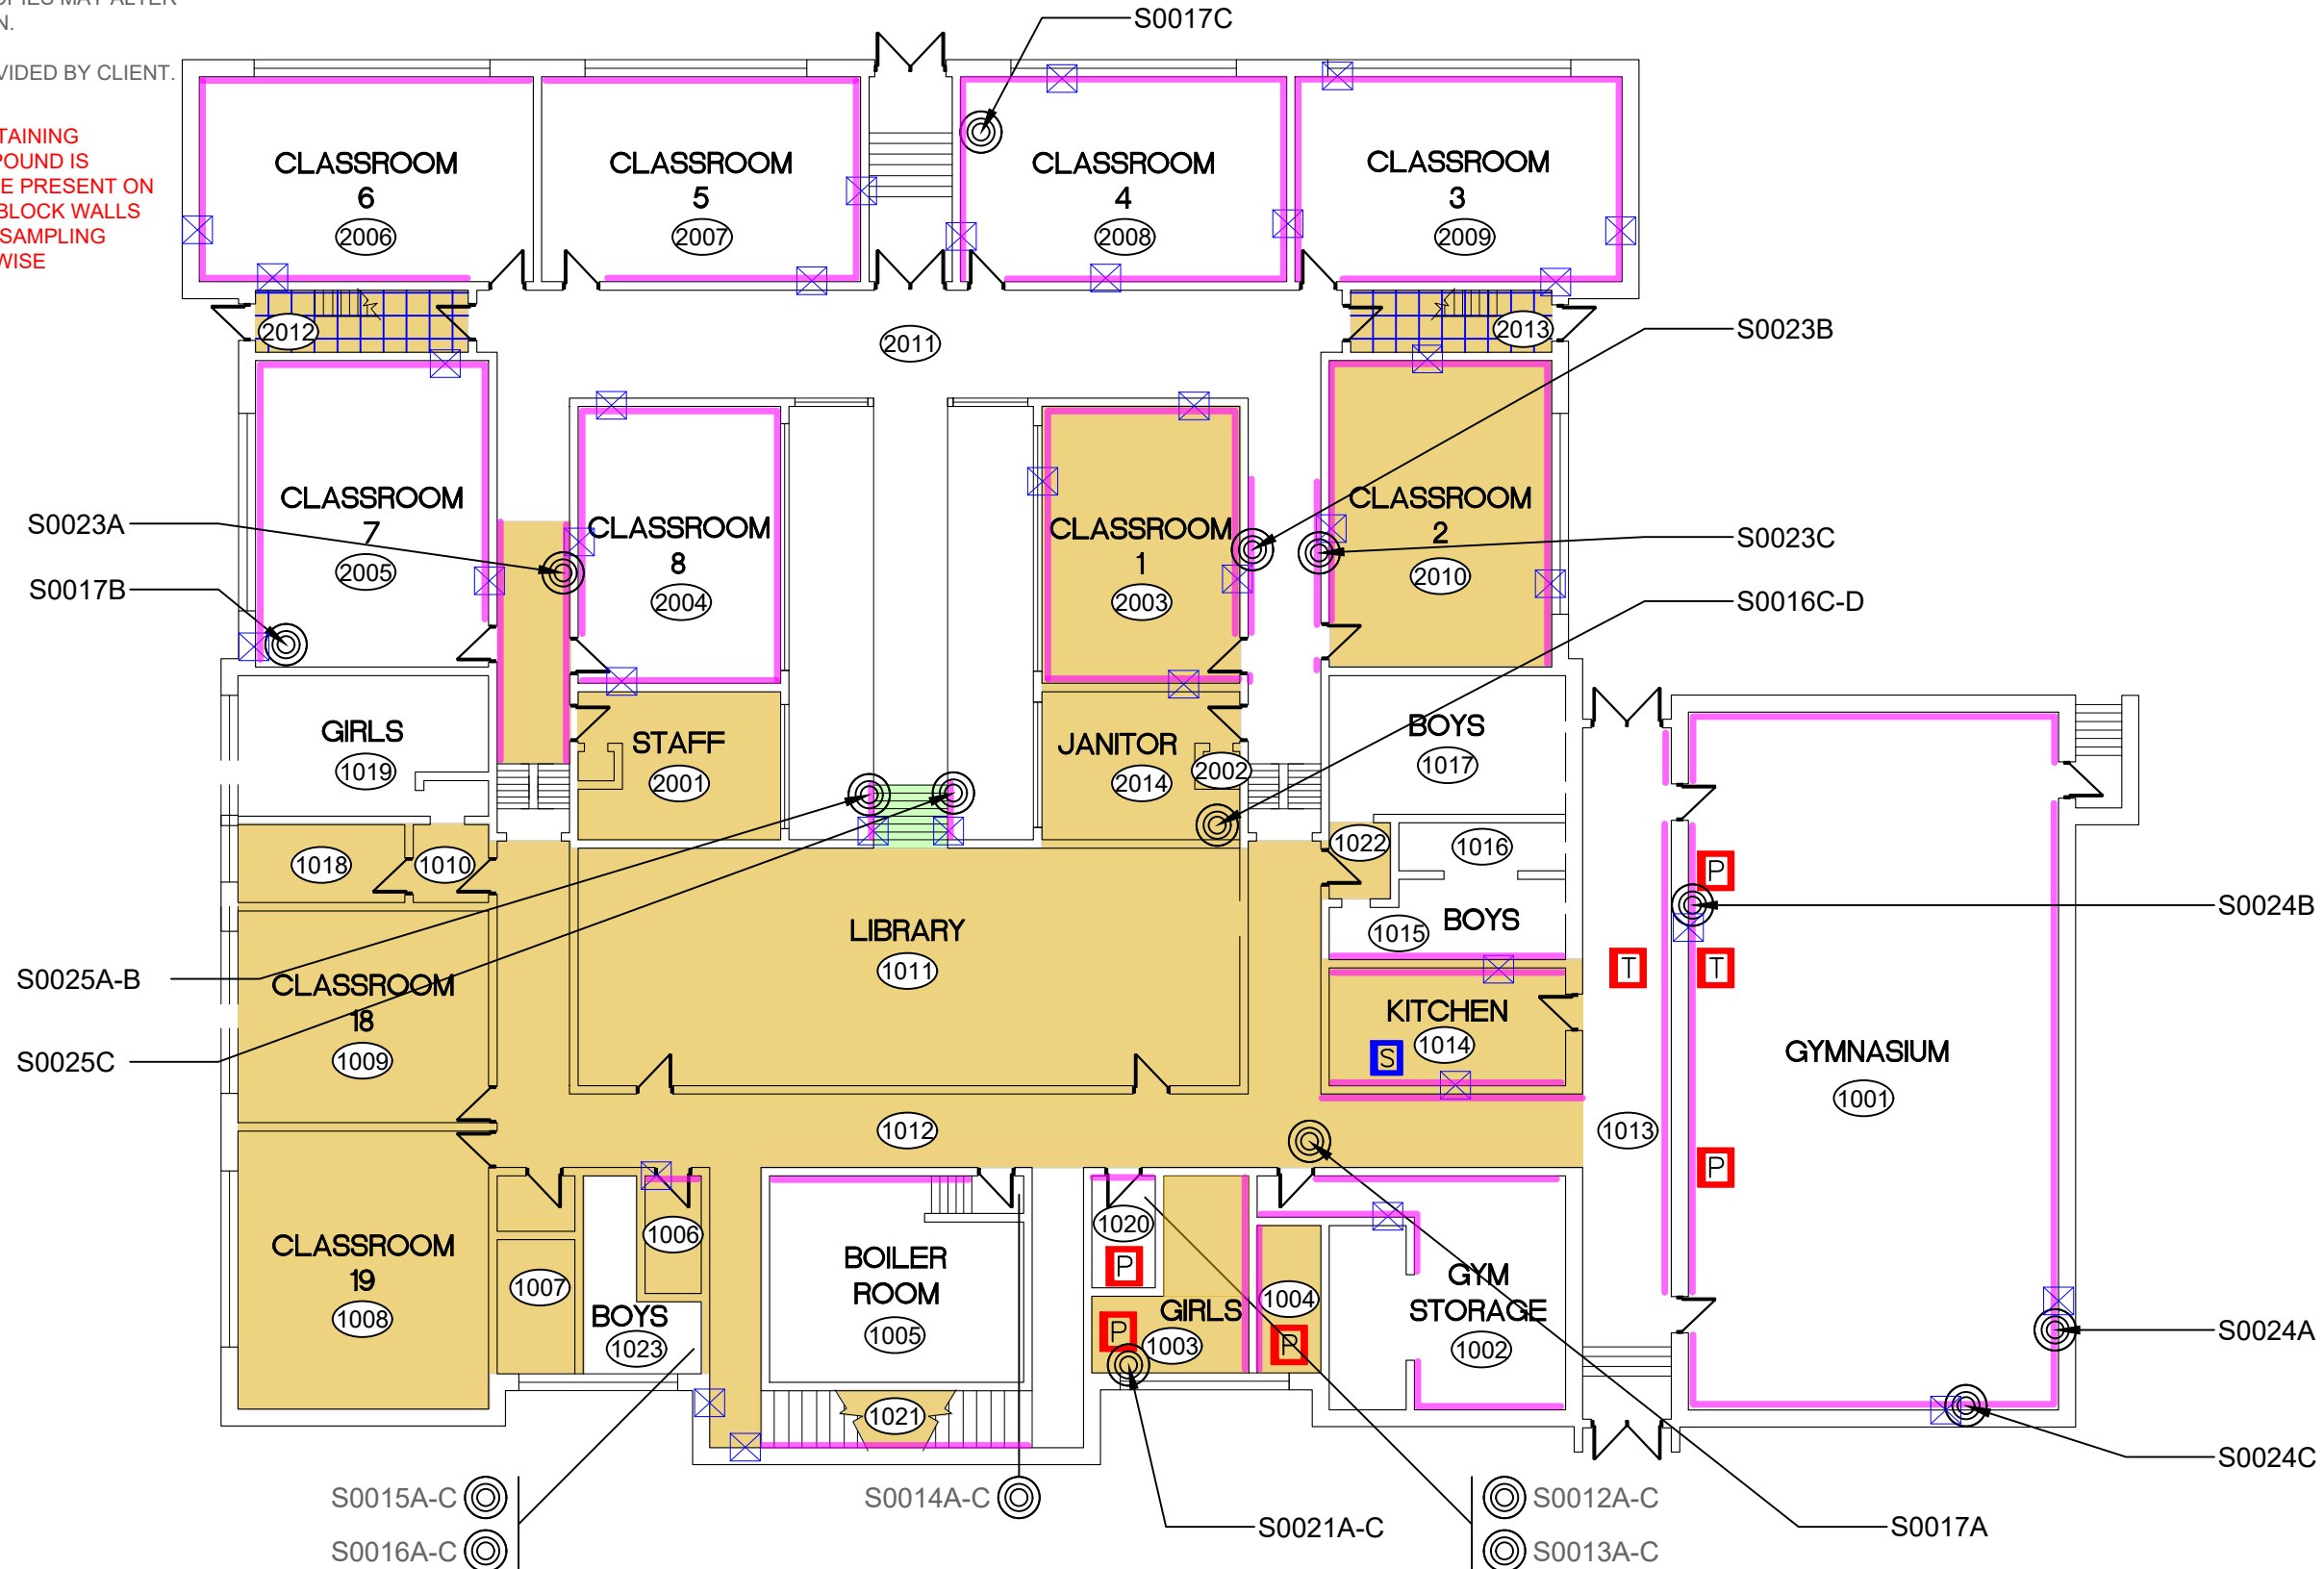
**NOTE:**  
ASBESTOS-CONTAINING COATING / COMPOUND IS PRESUMED TO BE PRESENT ON ALL CONCRETE BLOCK WALLS UNTIL FURTHER SAMPLING PROVES OTHERWISE

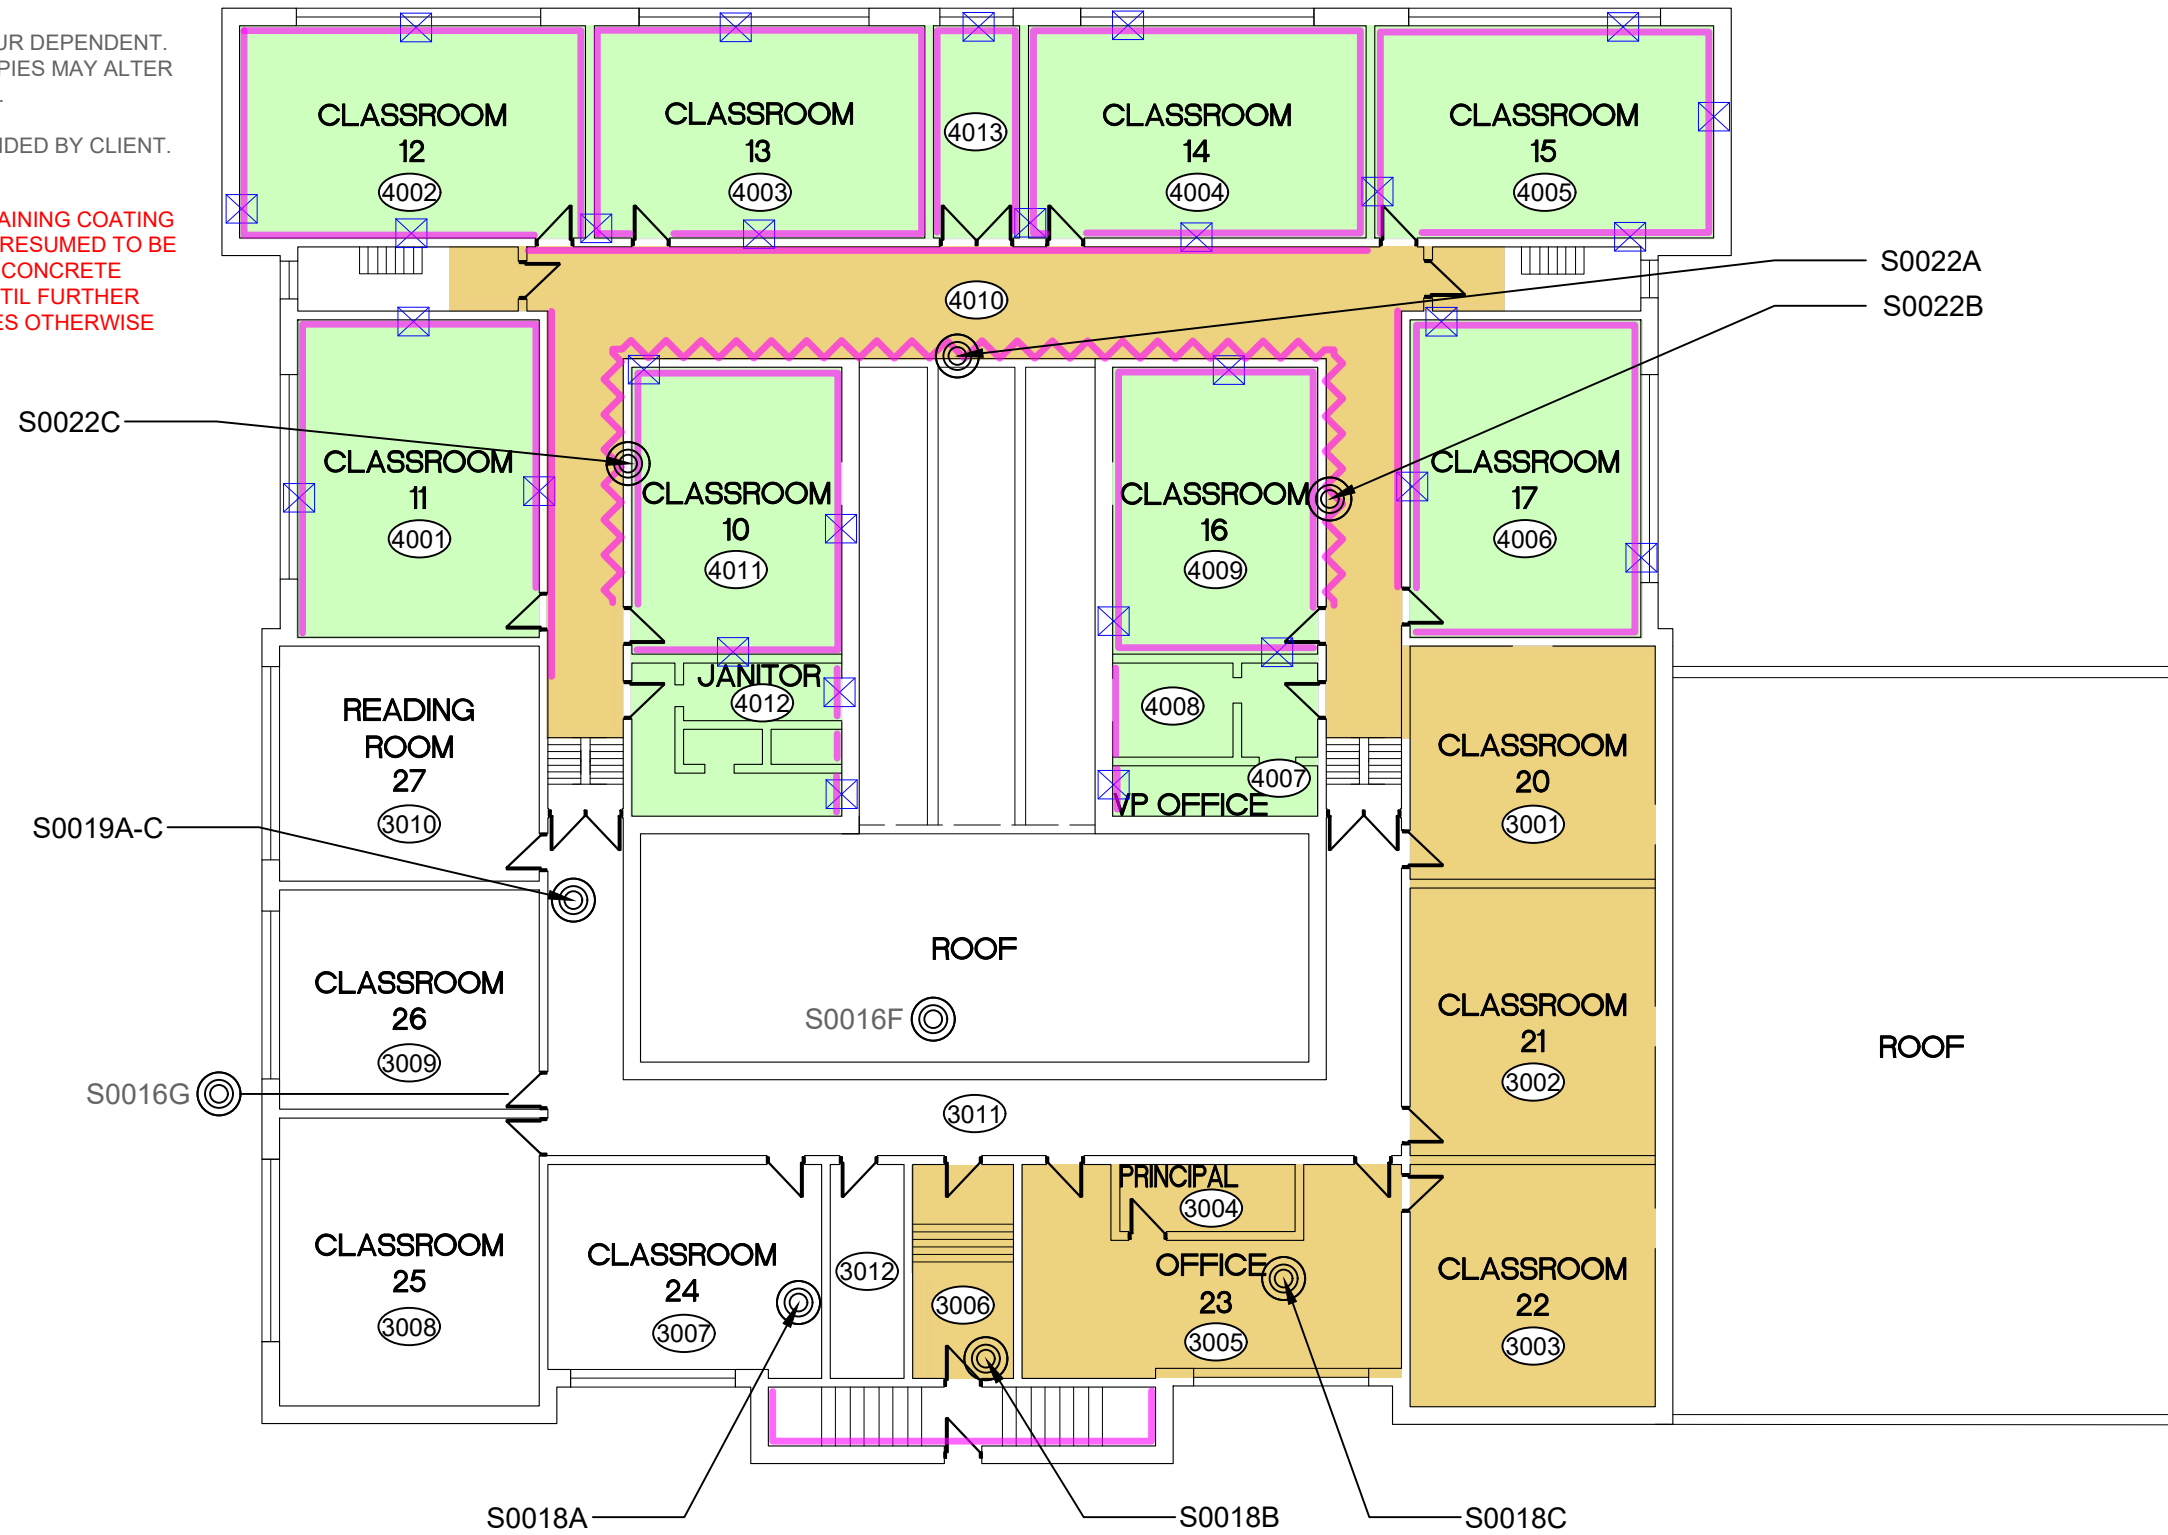
**NOTE:**  
ASBESTOS-CONTAINING COATING / COMPOUND IS PRESUMED TO BE PRESENT ON ALL CONCRETE BLOCK WALLS UNTIL FURTHER SAMPLING PROVES OTHERWISE
