Asbestos Assessment

St. Patrick
24 Smith Avenue, Hamilton, ON,
L8L 5P1

**Hamilton-Wentworth Catholic
District School Board**

August 31, 2023

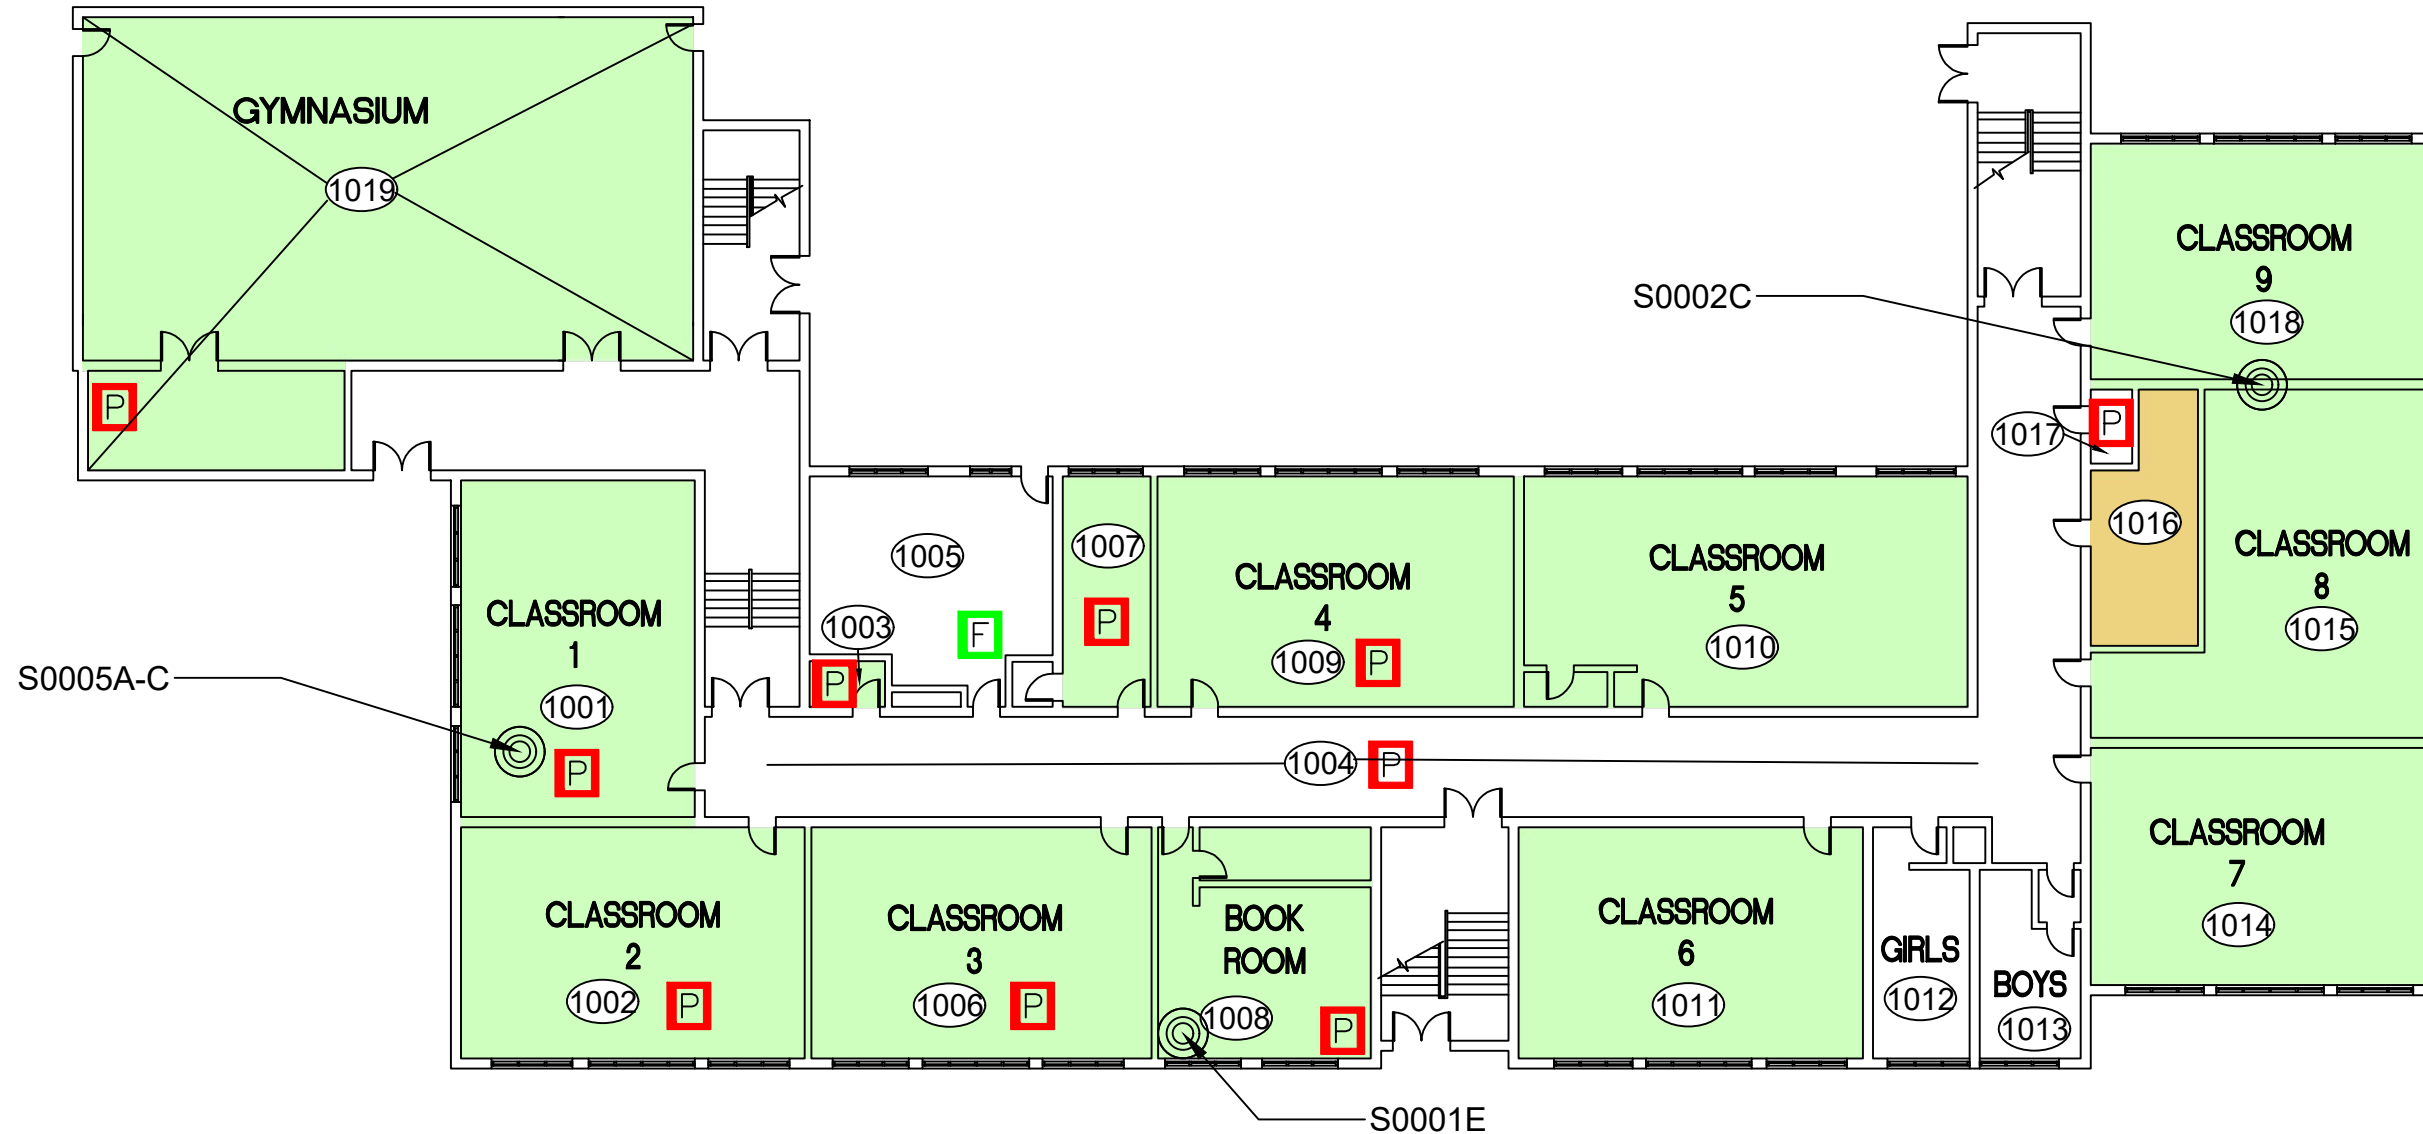
ASBESTOS-CONTAINING GLAZING PUTTY IS PRESENT BETWEEN GLASS AND FRAMES ON EXTERIOR WINDOWS THROUGHOUT THE BUILDING.

- P PARING CEMENT
- F FIRE DOOR
- T TRANSITE PANEL
- VINYL FLOOR TILES & MASTIC
- MASTIC

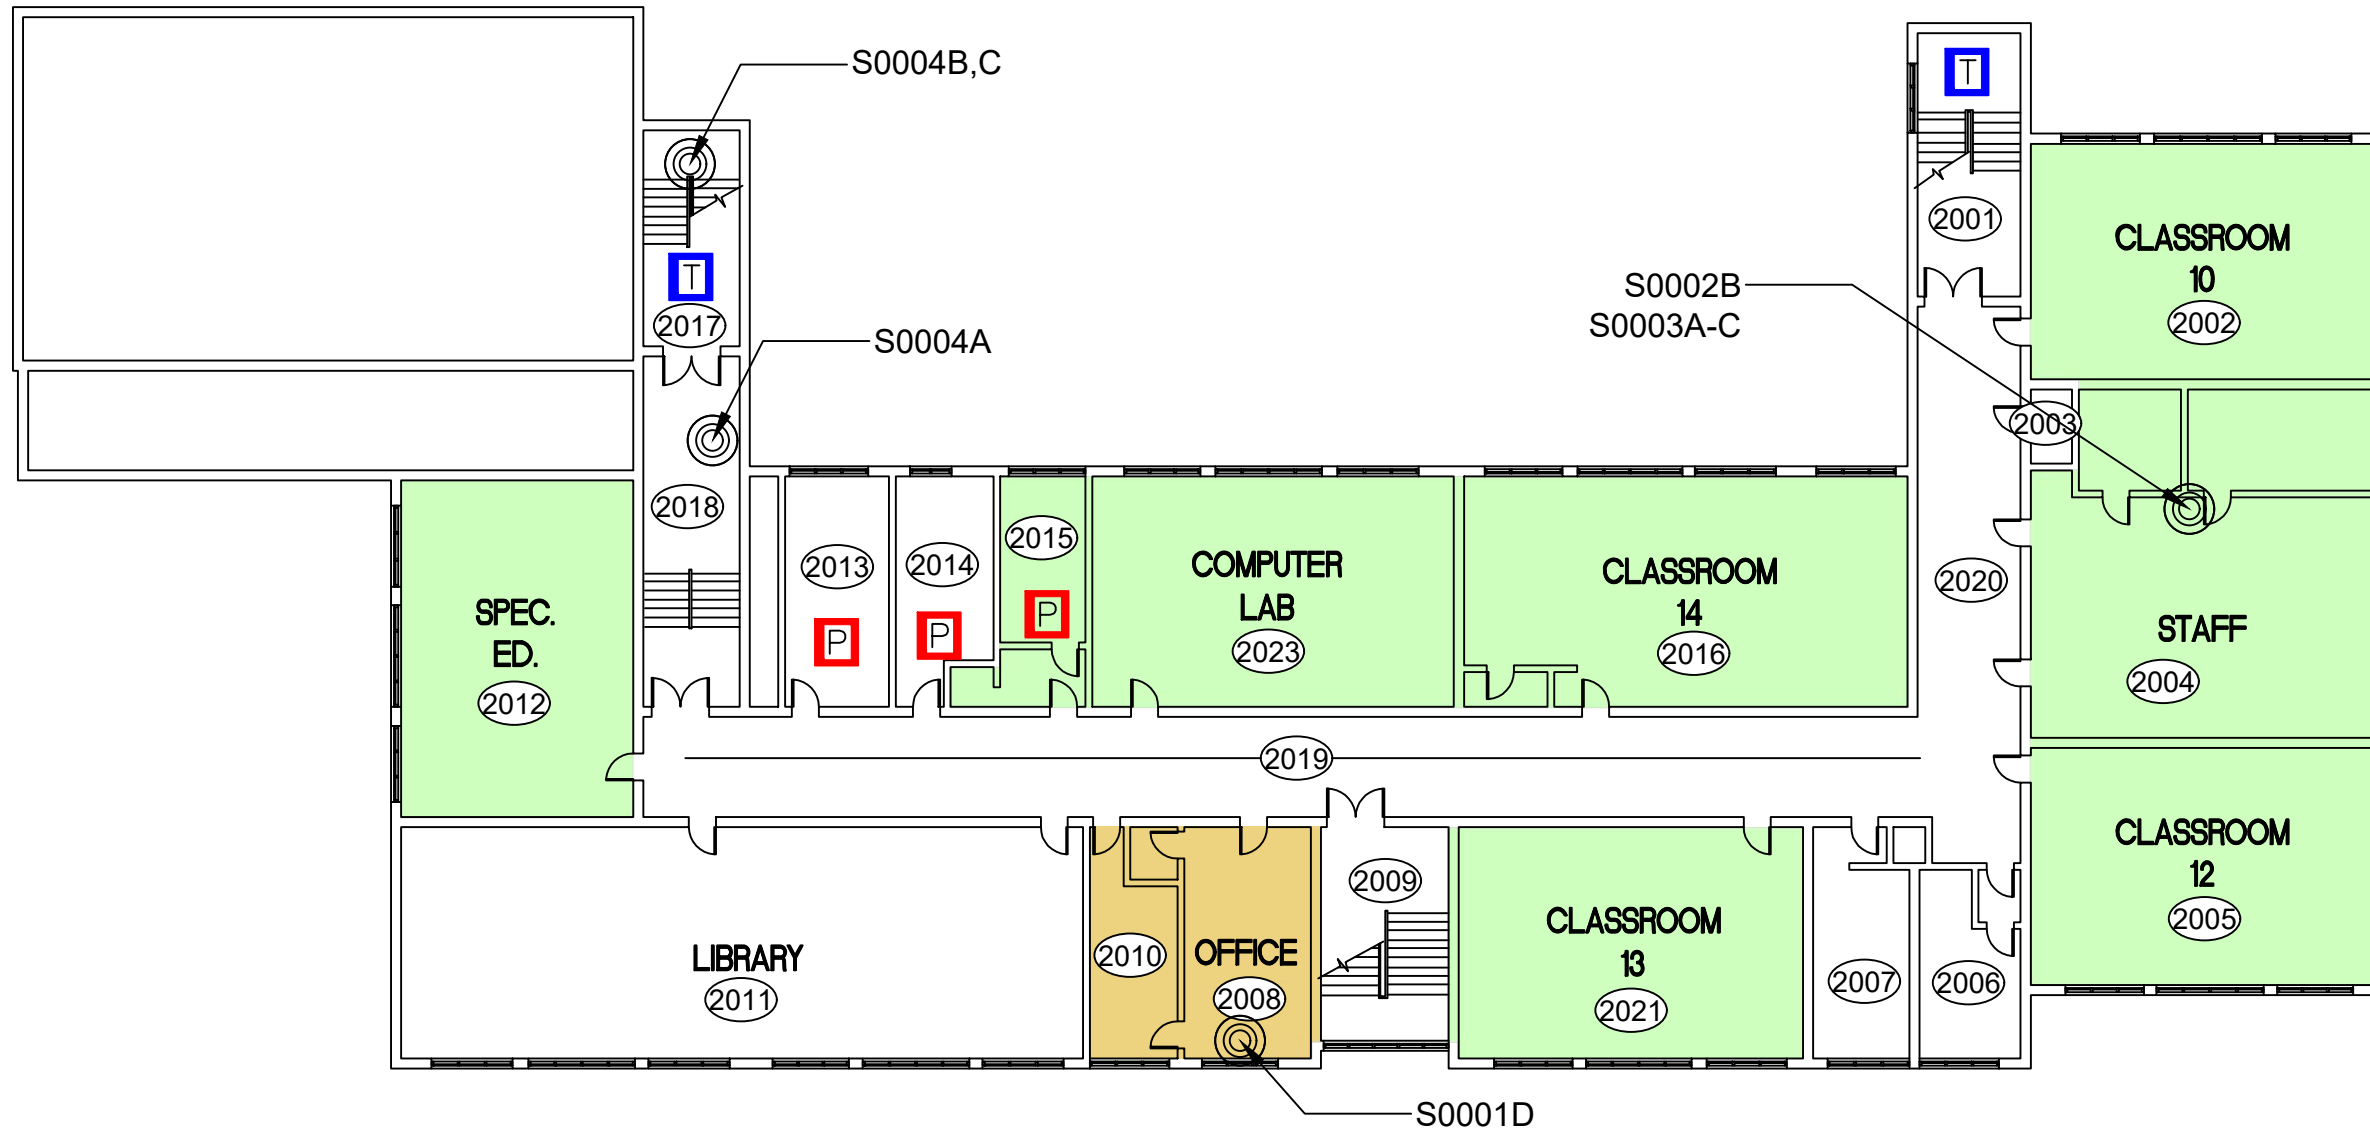
ASBESTOS-CONTAINING GLAZING PUTTY IS PRESENT BETWEEN GLASS AND FRAMES ON EXTERIOR WINDOWS THROUGHOUT THE BUILDING.

- P PARGING CEMENT
- F FIRE DOOR
- T TRANSITE PANEL
- VINYL FLOOR TILES & MASTIC
- MASTIC

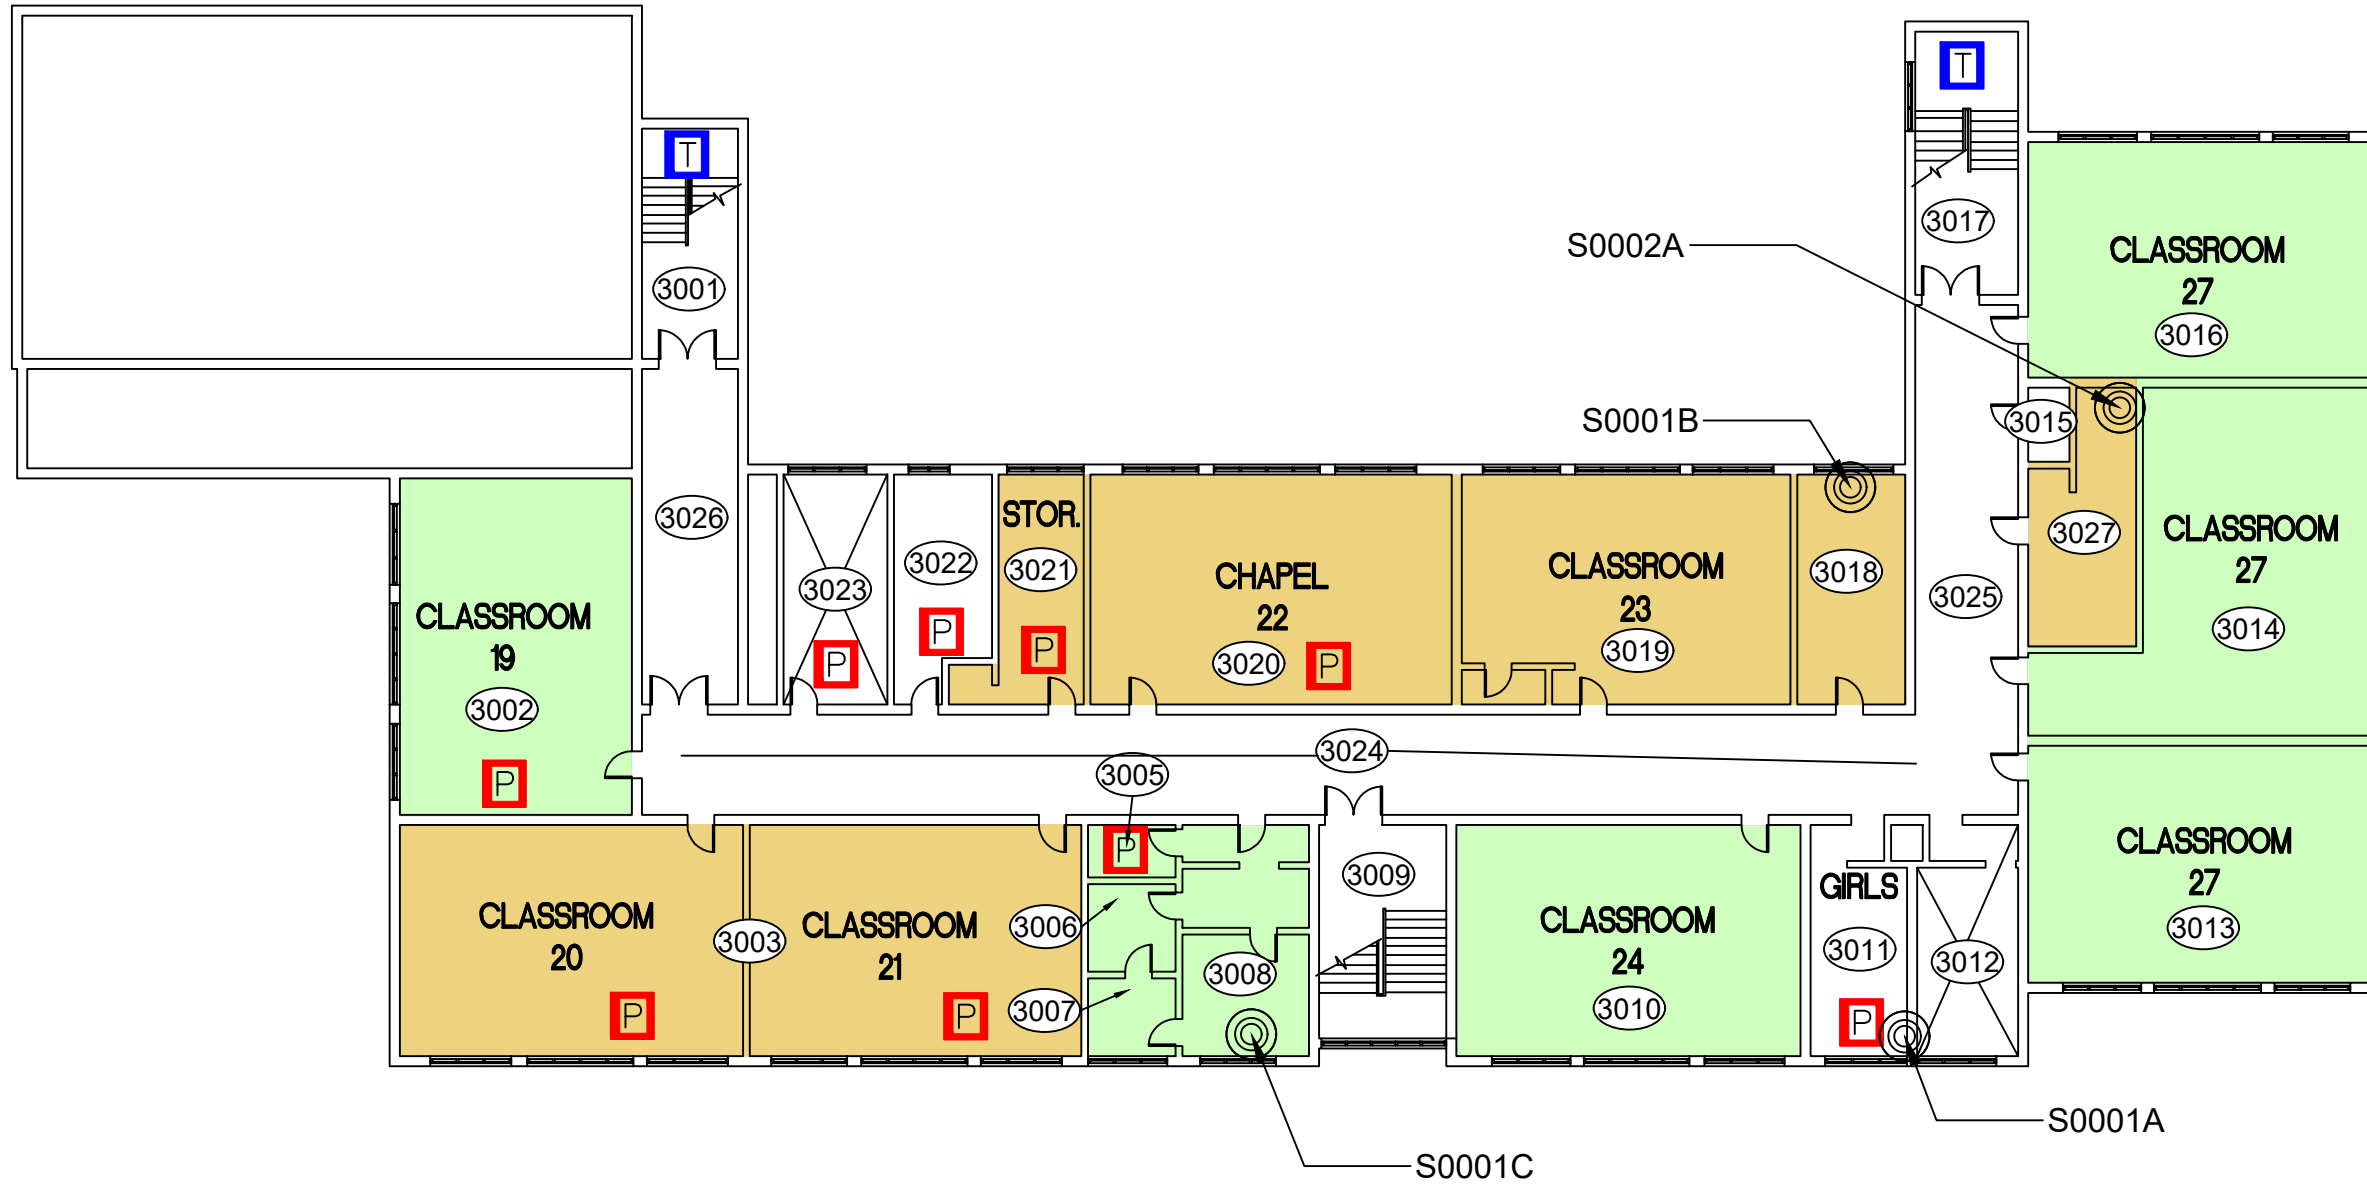
- P PARGING CEMENT
- F FIRE DOOR
- T TRANSITE PANEL
- VINYL FLOOR TILES & MASTIC
- MASTIC
