Asbestos Assessment

Annunciation of Our Lord
250 Limeridge Road West,
Hamilton, ON, L9C 2V2

**Hamilton-Wentworth Catholic
District School Board**

August 31, 2023

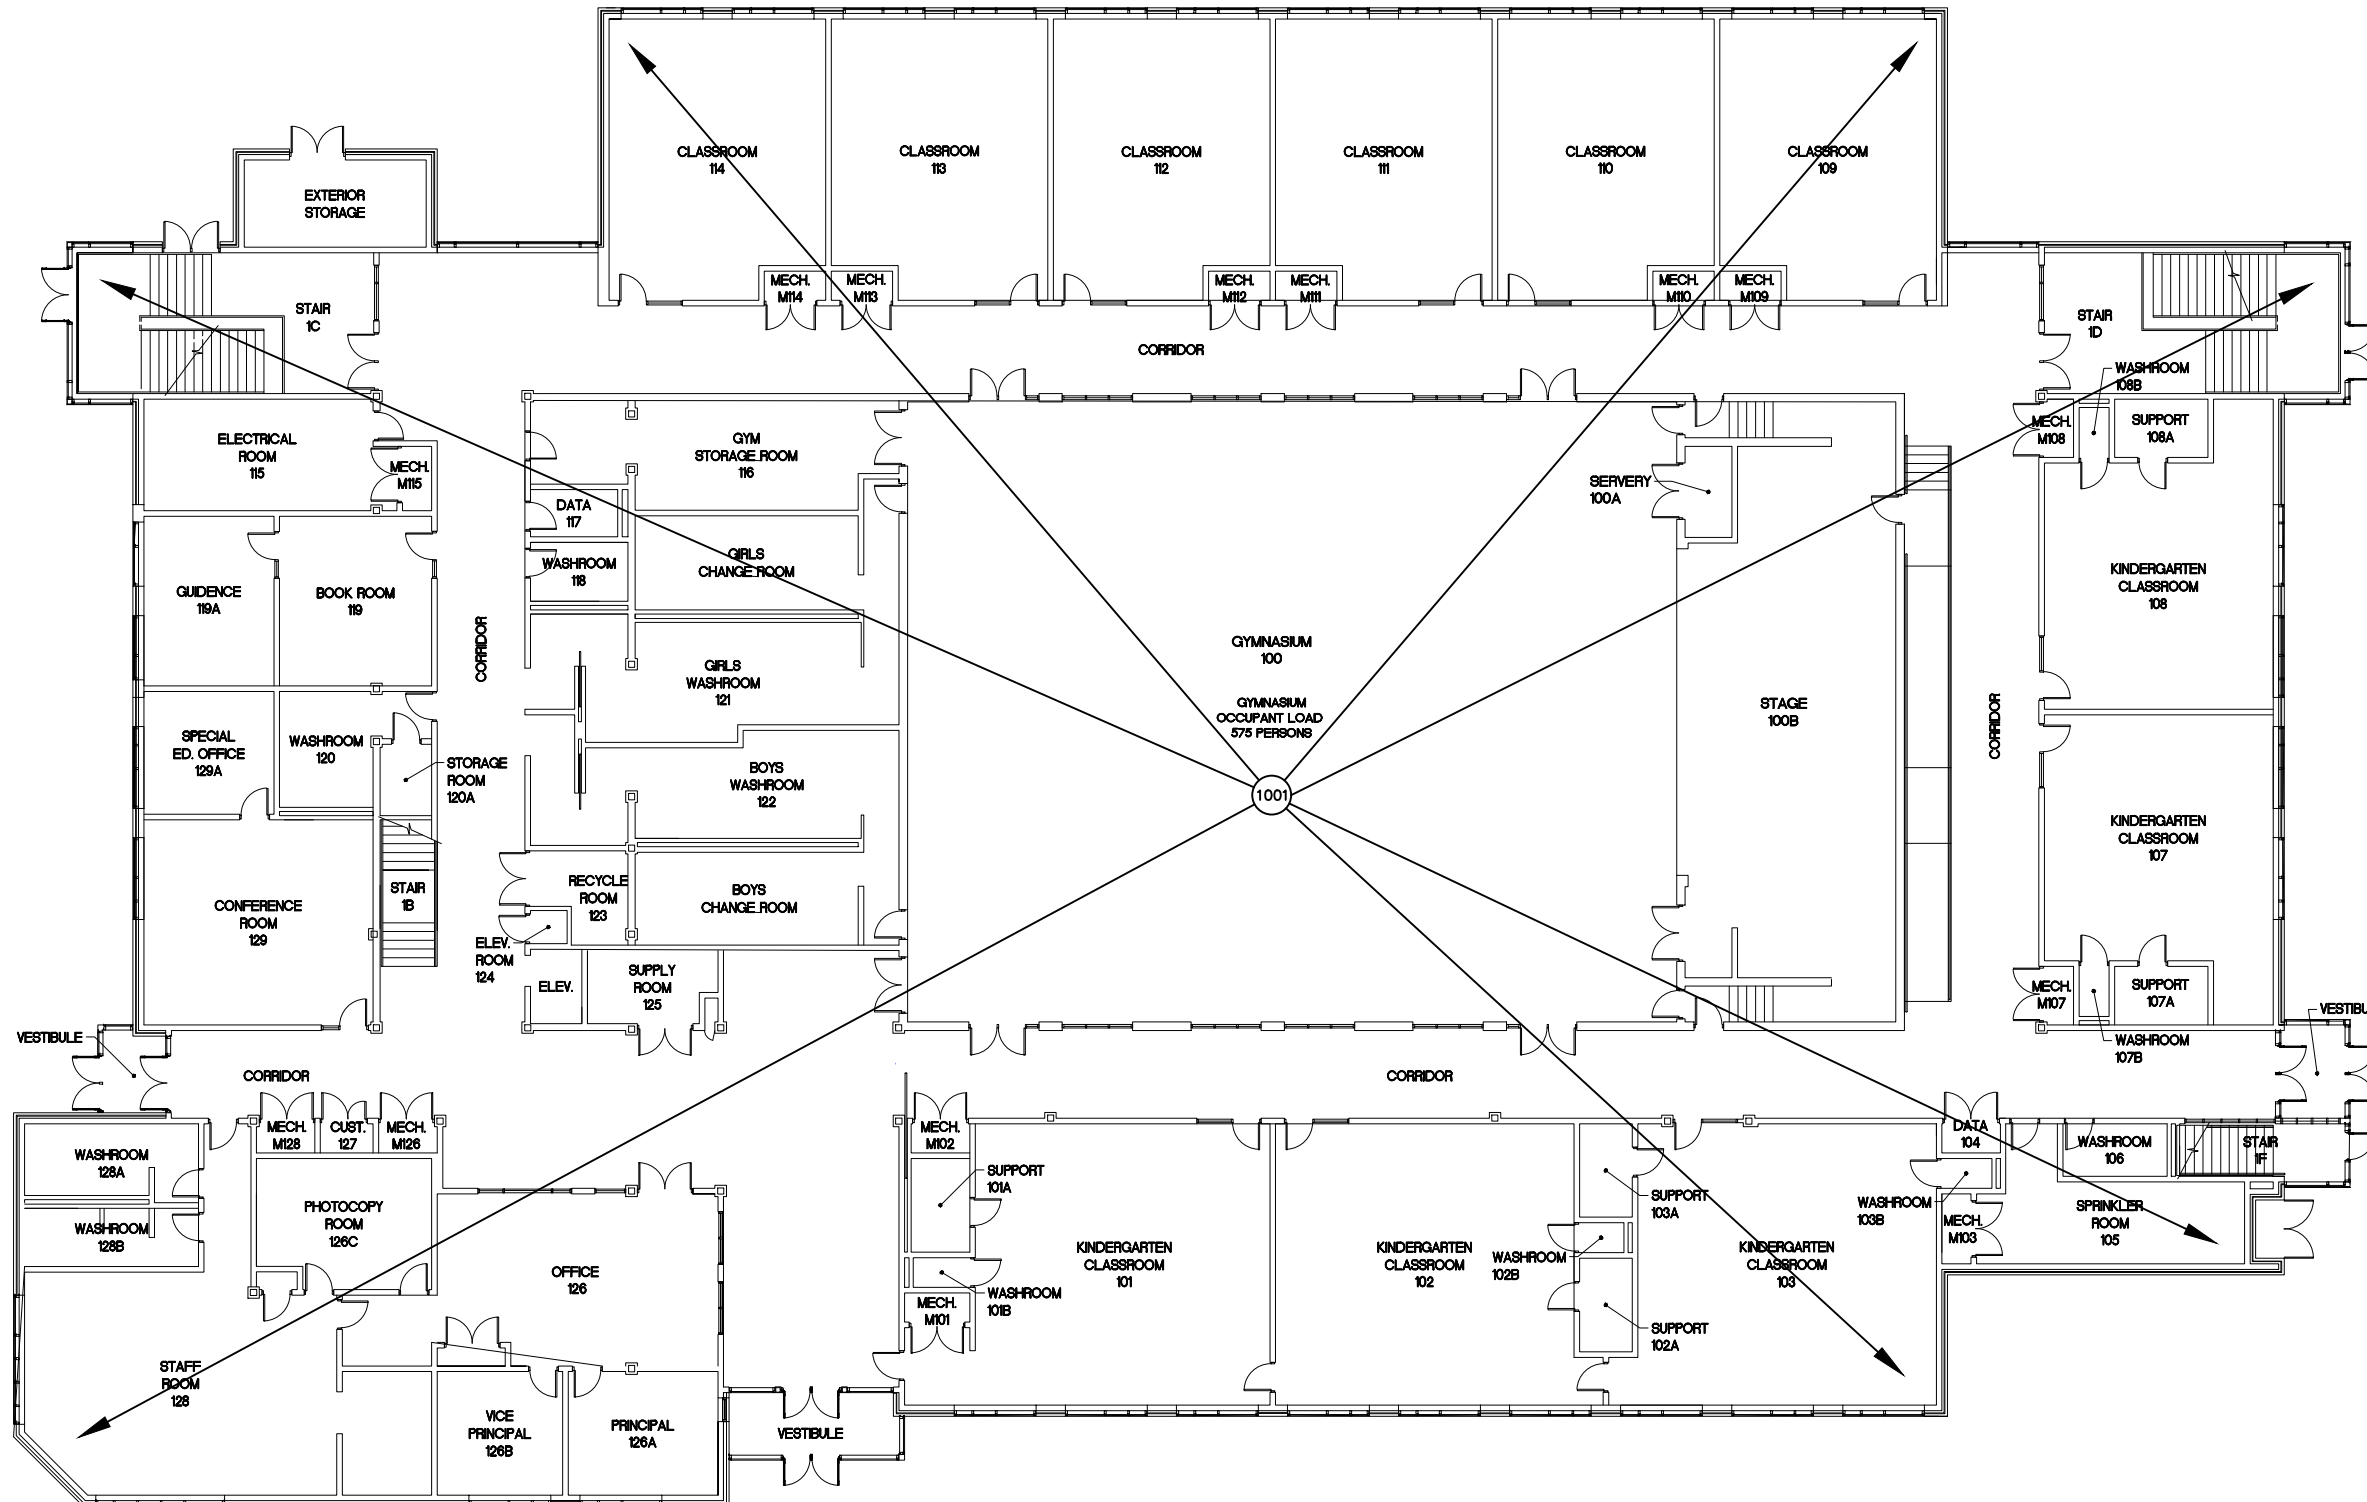
NOT ALL KNOWN OR SUSPECTED ASBESTOS BUILDING MATERIALS MAY BE DEPICTED ON THE DRAWING. REFER TO THE ASBESTOS ASSESSMENT REPORT FOR A COMPLETE LIST OF KNOWN AND SUSPECTED ASBESTOS BUILDING MATERIALS.

Information regarding the location and condition of ACM encountered and visually estimated quantities were recorded. The locations of any samples collected were recorded on small-scale plans. As-built drawings and previous reports were referenced where provided.

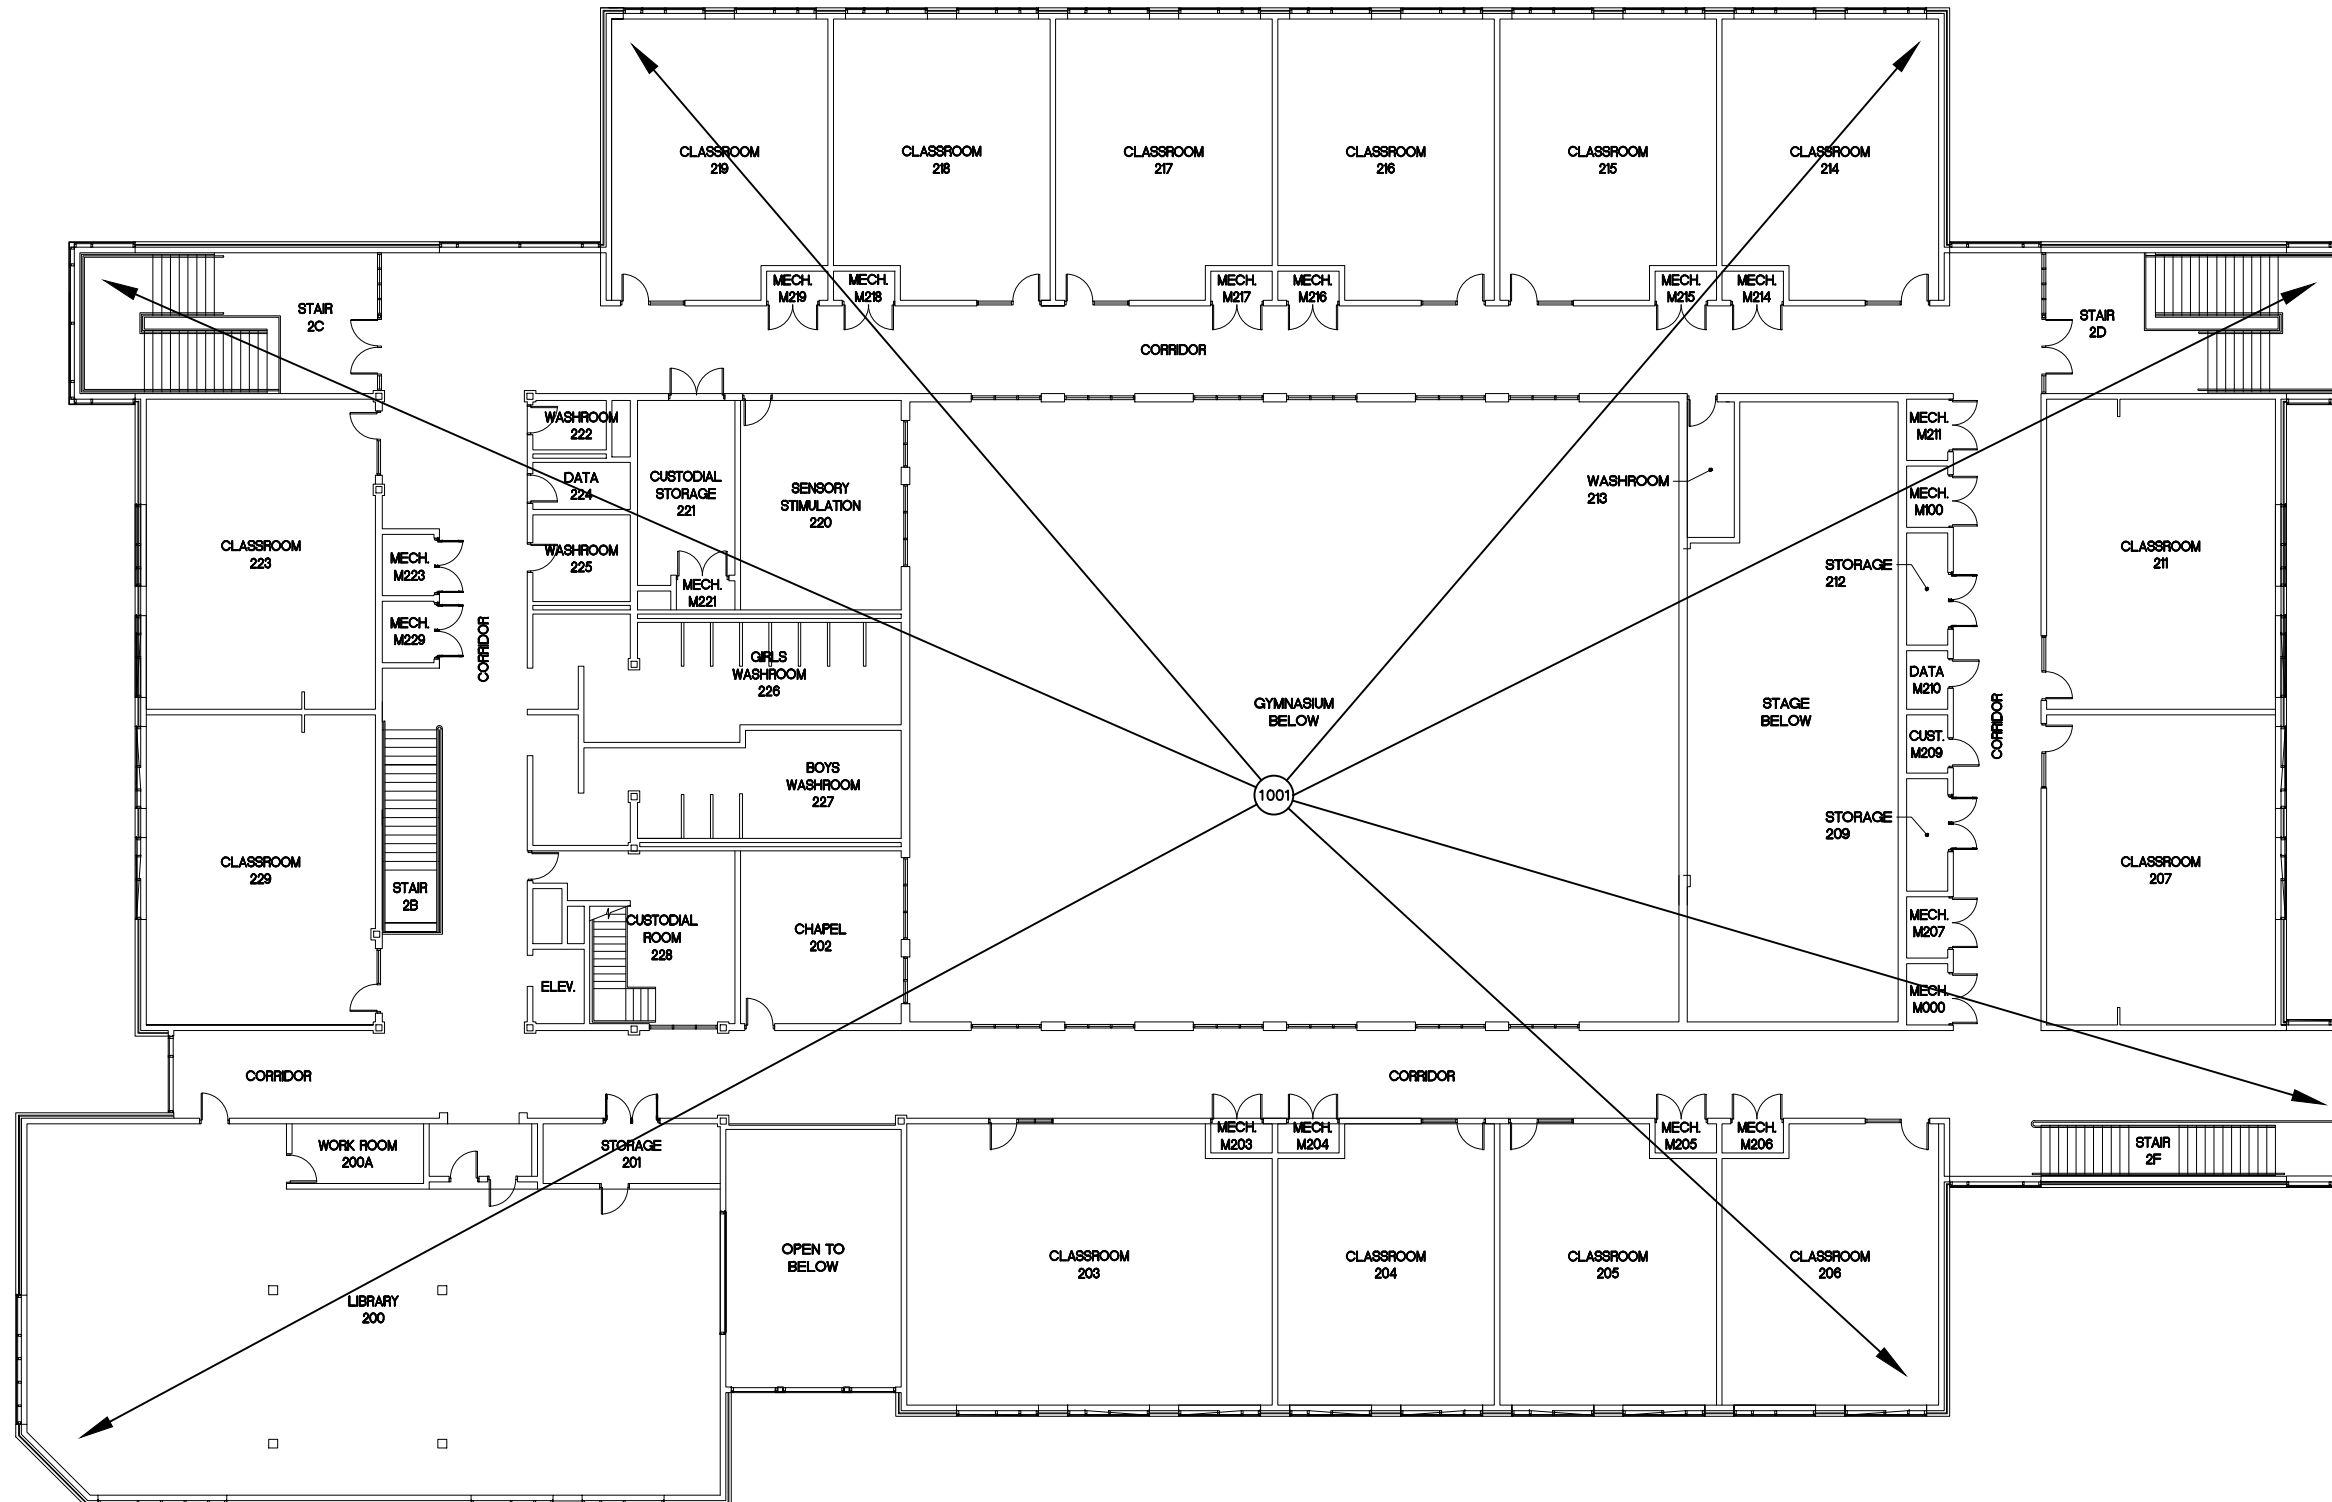
NOT ALL KNOWN OR SUSPECTED ASBESTOS BUILDING MATERIALS MAY BE DEPICTED ON THE DRAWING. REFER TO THE ASBESTOS ASSESSMENT REPORT FOR A COMPLETE LIST OF KNOWN AND SUSPECTED ASBESTOS BUILDING MATERIALS.
