# Asbestos Reassessment

St. Bernadette  
270 Governors Road, Dundas,  
Ontario

**Hamilton-Wentworth Catholic  
District School Board**

May 15, 2023

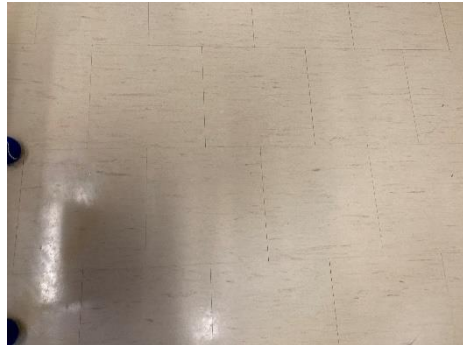
Material and Application	Asbestos Type	Photo
Mechanical equipment is either uninsulated or insulated with non-asbestos fibreglass.	None	
All ceiling tiles are presumed to be non-asbestos based on the age of the building (1991).	None	
Asbestos in drywall joint compound was banned in Canada in 1980. Drywall joint compound in the building was installed after 1986 (1980 plus a reasonable non-compliance period based on our experience) and is assumed to contain no asbestos.	None	
Vinyl floor tiles (12"x12") and mastic throughout the building are all non-asbestos based on laboratory analysis.	None Detected (tile) None Detected (mastic)
