Asbestos Assessment

St. Mary
200 Whitney Ave, Hamilton, ON,
L8S 2G7

**Hamilton-Wentworth Catholic
District School Board**

August 31, 2023

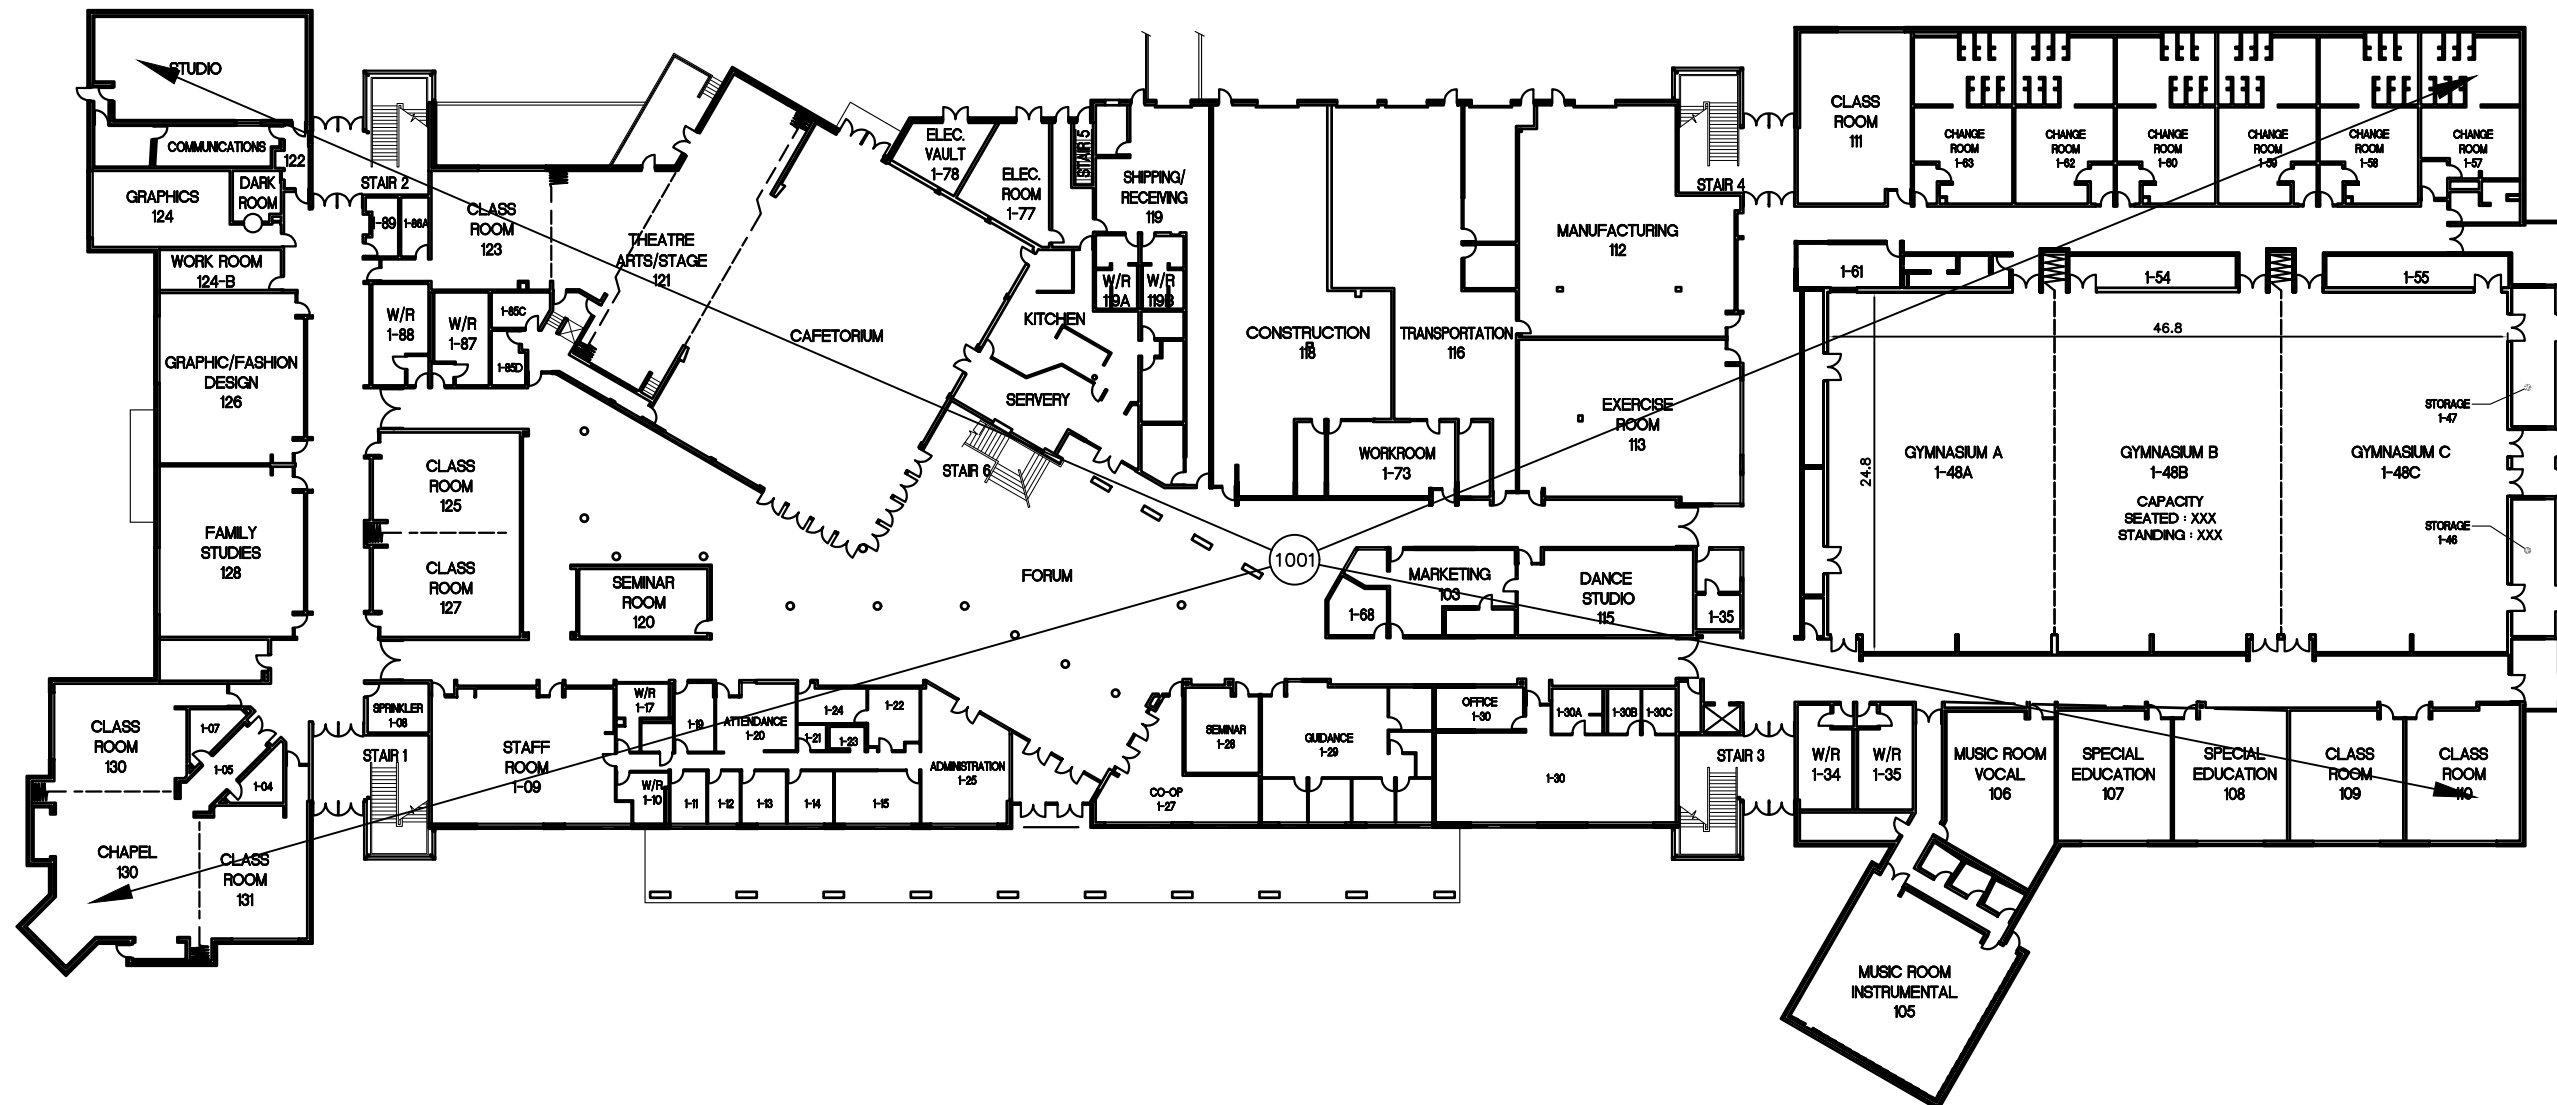
LEGEND:

(X) LOCATION NUMBER

Information regarding the location and condition of ACM encountered and visually estimated quantities were recorded. The locations of any samples collected were recorded on small-scale plans. As-built drawings and previous reports were referenced where provided.
