Asbestos Assessment

St. Thérèse Of Lisieux
1760 Garth Street, Hamilton, ON,
L9B 2X5

**Hamilton-Wentworth Catholic
District School Board**

August 31, 2023

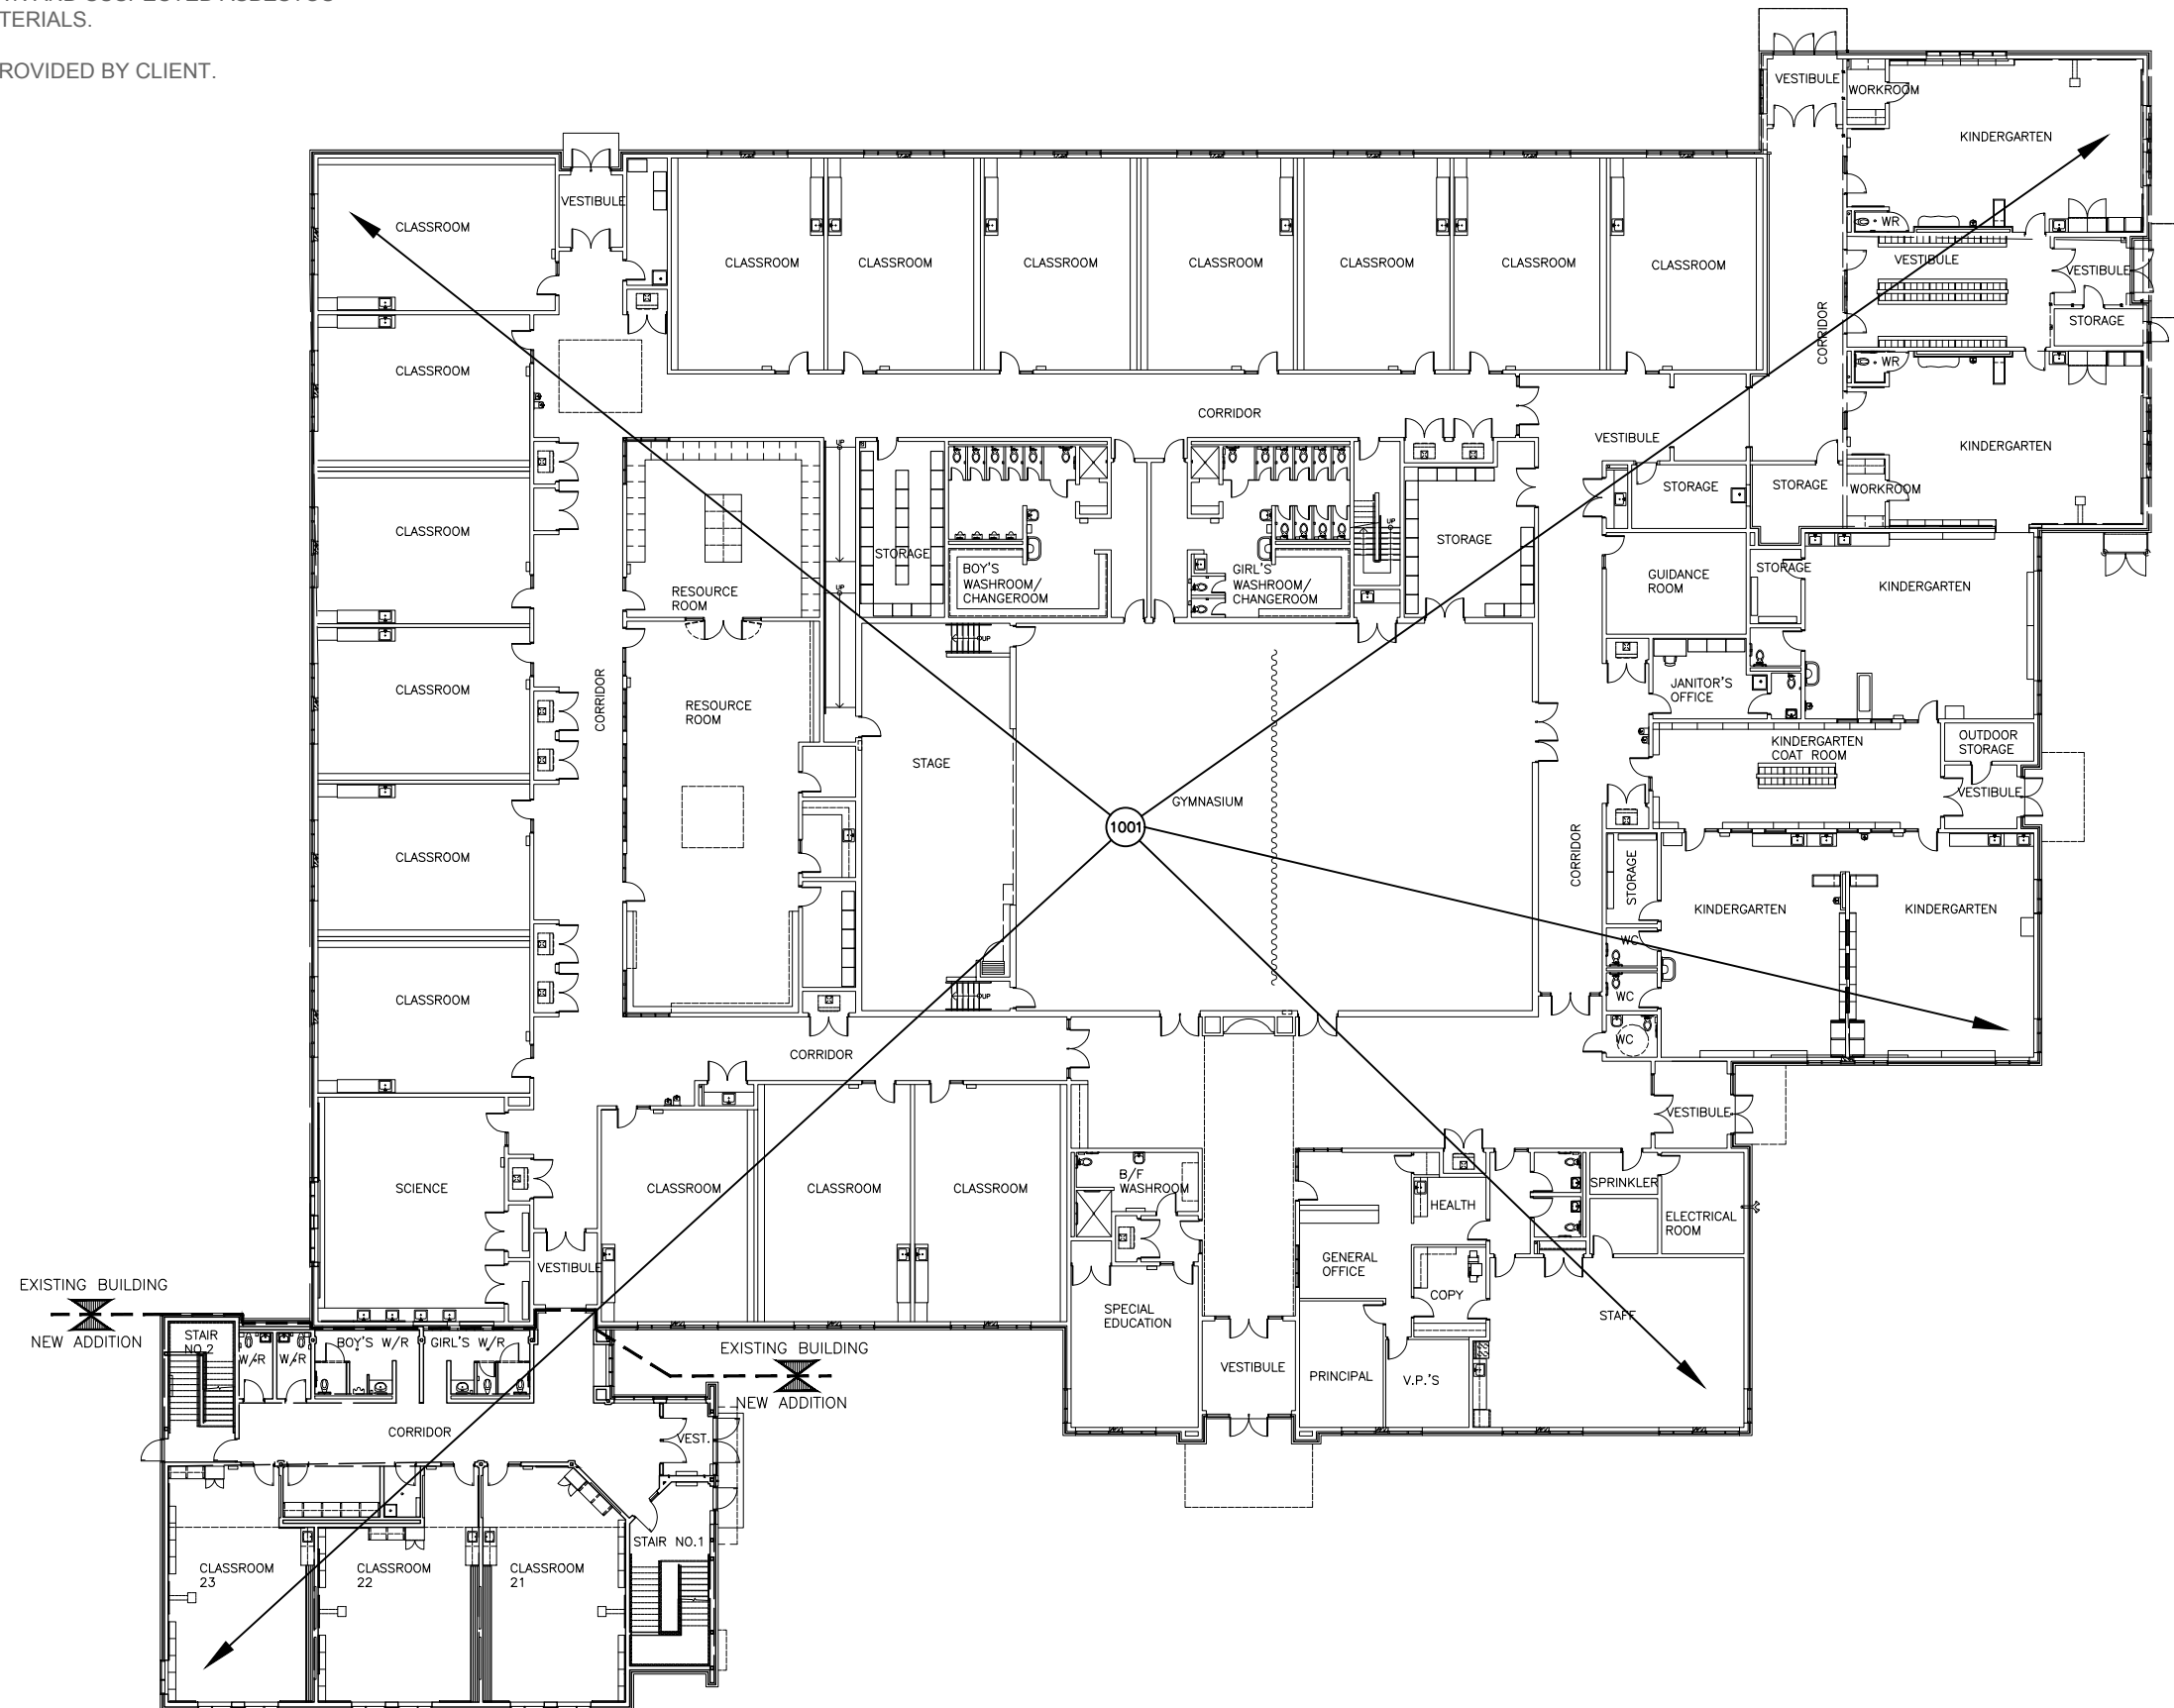
NOT ALL KNOWN OR SUSPECTED ASBESTOS BUILDING MATERIALS MAY BE DEPICTED ON THE DRAWING. REFER TO THE ASBESTOS ASSESSMENT REPORT FOR A COMPLETE LIST OF KNOWN AND SUSPECTED ASBESTOS BUILDING MATERIALS.

(X) LOCATION NUMBER

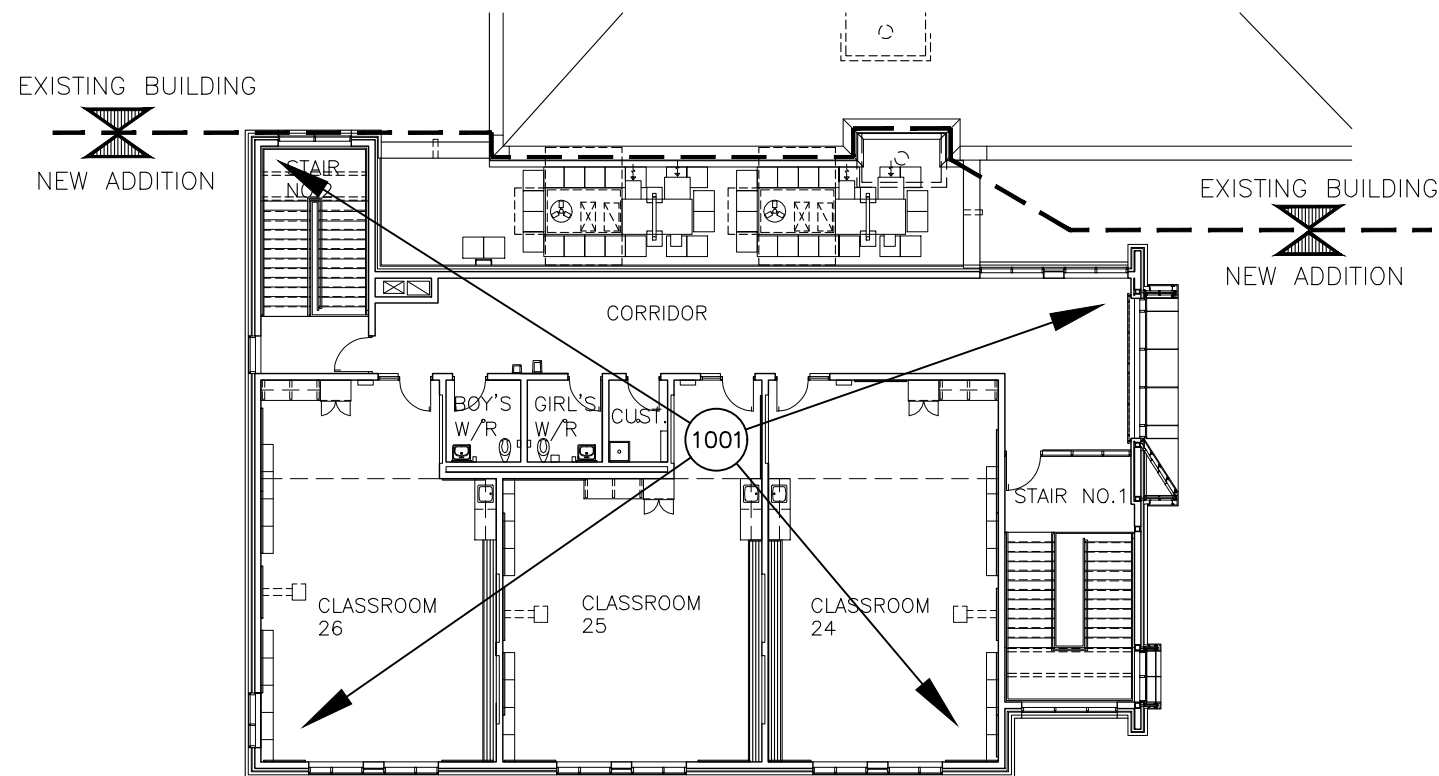
NOT ALL KNOWN OR SUSPECTED ASBESTOS BUILDING MATERIALS MAY BE DEPICTED ON THE DRAWING. REFER TO THE ASBESTOS ASSESSMENT REPORT FOR A COMPLETE LIST OF KNOWN AND SUSPECTED ASBESTOS BUILDING MATERIALS.

(X) LOCATION NUMBER
